Using Basic Quality Tools to Improve Production Yields and Product Quality in Manufacturing

A thesis

Master of Science in Technology with a concentration in Engineering Technology

December 2015

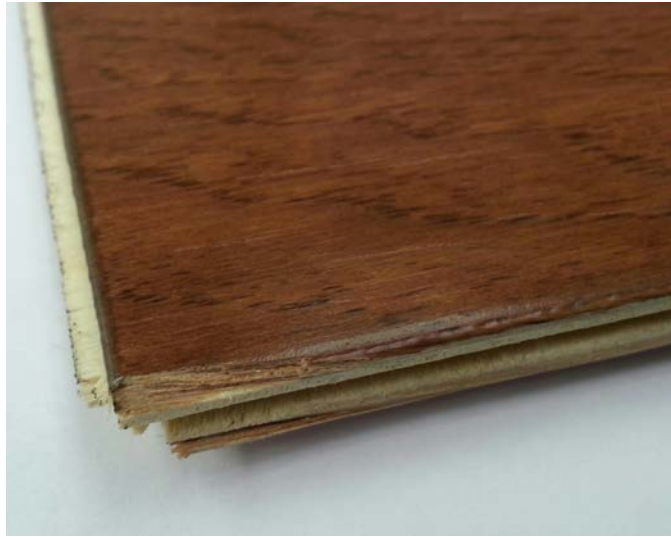
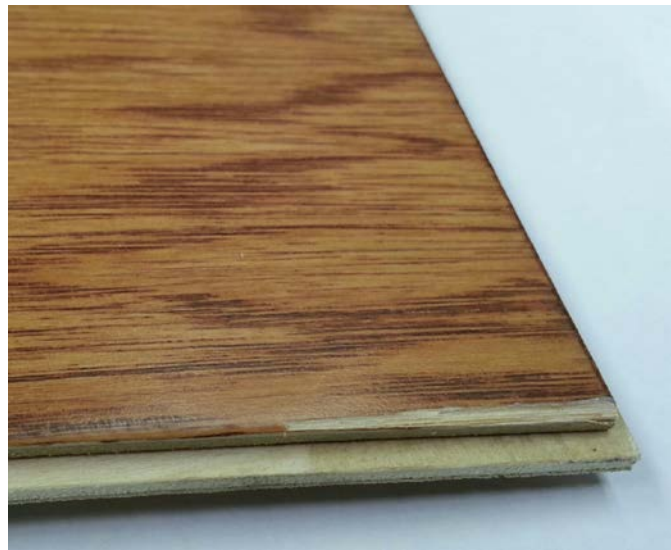
End chip-out occurs on the end corners of flooring after it is end-matched with a tongue & groove or click locking profile. Chipping out of the corners creates a void noticeable when installing flooring (Figure 1).

Flooring milled from engineered panels both 3/8" and 1/2" thick require milling a side and end bevel, and tongue & groove as part of the product manufacturing process. During this process, chip-out on the leading and trailing corners of the flooring are created, this causes a void on the corners of the product that stands out as an unstained area (Figure 1).

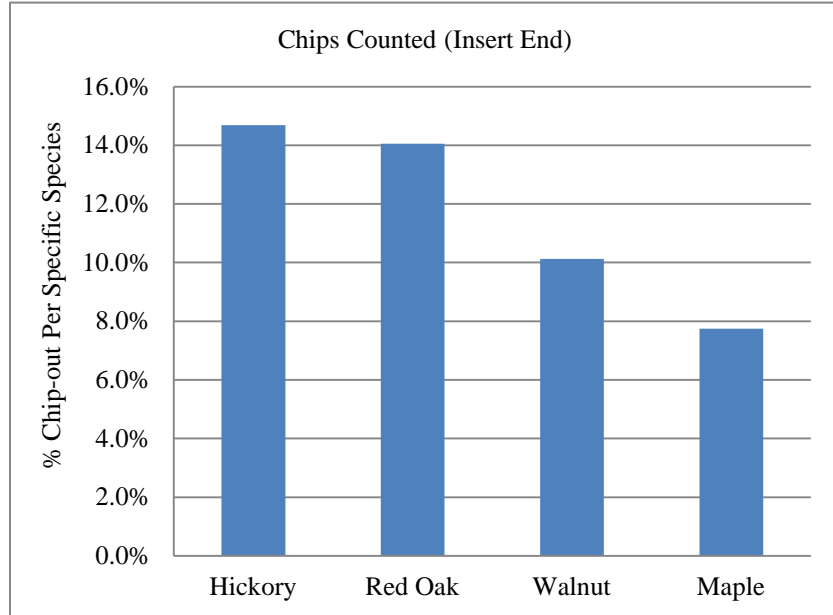
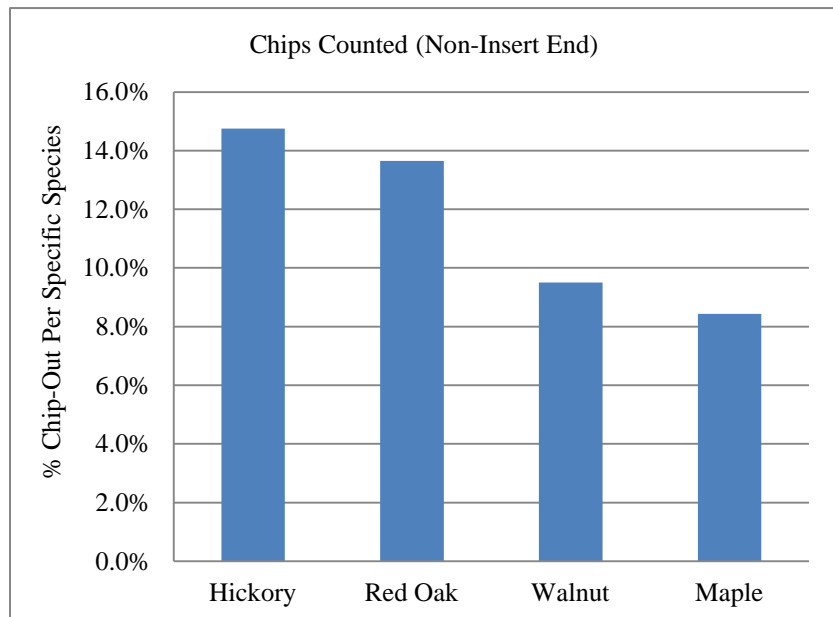
Table 4: Percent of Chip-out With-in Specific Species

Data collected during the two week sampling process was documented on a tally sheet, Table 3, and then an overall percentage of chips found during the two week period were displayed on a bar chart as seen in Table 4. In order to determine if one end of the flooring is more susceptible to chip-out than the other, each end of the flooring was identified separately and labeled as to its function, either insert end, or non-insert end.

During the analyze phase of the DMAIC process, data collected was analyzed by first determining the overall percent of chips found for each species of wood sampled. The results of the data clearly shows that across all four wood species, chips exceeding total allowable defects of 5% or less were present; in addition chip-out was more prevalent in the hickory and red oak species, than in the walnut and maple species. This is consistent with what is expected of each species given their structural fiber make-up.

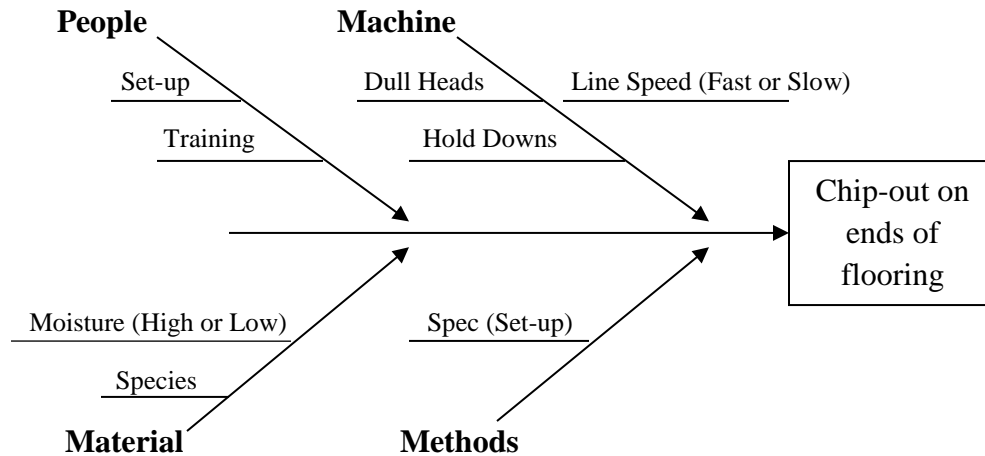
According to the American Society for Quality (ASQ), an on-line quality publication, the cause-and-effect diagram, otherwise known as the Fishbone (Ishikawa) Diagram, is one of seven basic quality tools, and is used to list many possible causes or problems (Tague, 2005). The diagram in Figure 6 lists four categories that the most probable cause of chip-out will fall under (people, machine, material, and methods). Each main category was subdivided into sub categories in order to list more specific causes of chip-out under the four main causes.

Figure 6: Cause and Effect Diagram Listing Most Probable Causes of Chip-Out

- **Methods:** Manufacturers Specifications for machine set-up are acceptable and ruled out as a contributing factor to chip-out.
- **Material:** Moisture (High or Low); Figure 11 shows that moisture samples taken from the same run as the chipped material samples were taken concludes high or low moisture was not a contributing factor to chip-out. See “Wood Moisture Content” section for details.
- **Machine:** Line speeds were adjusted at different rates during a test run and determined to not be a contributing factor to chip-out. Hold downs that maintain constant positioning of the flooring as it goes through the milling process we properly adjusted and also determined not to be a contributing factor to chip-out.

- People:** When evaluating the operator set-up process, it was discovered that this process was not consistently followed; in addition, each operator's set-up was slightly different based on their experience level. Operator training is another factor to consider as no standard training processes are in place. Both Operator set-up and the lack of operator set-up training were identified as contributing factors to chip-out.

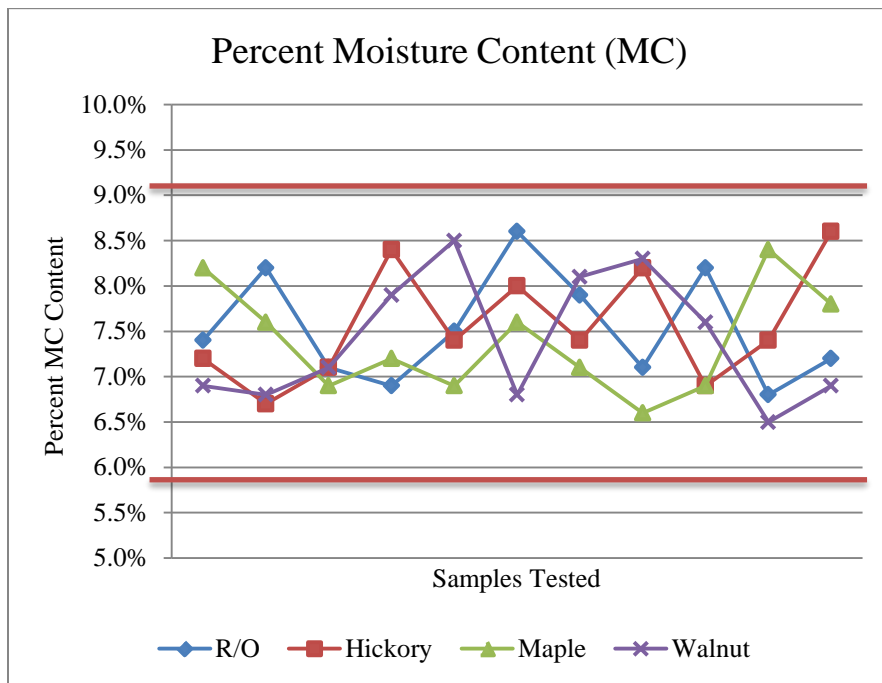
Table 5: Moisture Content (MC) Results from Test Samples

Green Weight – Dry Weight / Dry Weight = Percent Moisture Content (MC)

Desired MC = 6-9 Percent.

The formula used to determine moisture content (MC) as a percentage of overall sample weight is as follows: $MC\% = (A-B) / B \times 100$ where A = original mass (green weight), and B = over dried mass (dry weight). In Table 5 the results of the samples tested for moisture as being a contributing factor to chip-out are listed. Results of the data show that moisture content being too high or too low is not a contributing factor to chip-out and thus, material as a cause of chip-out is eliminated.

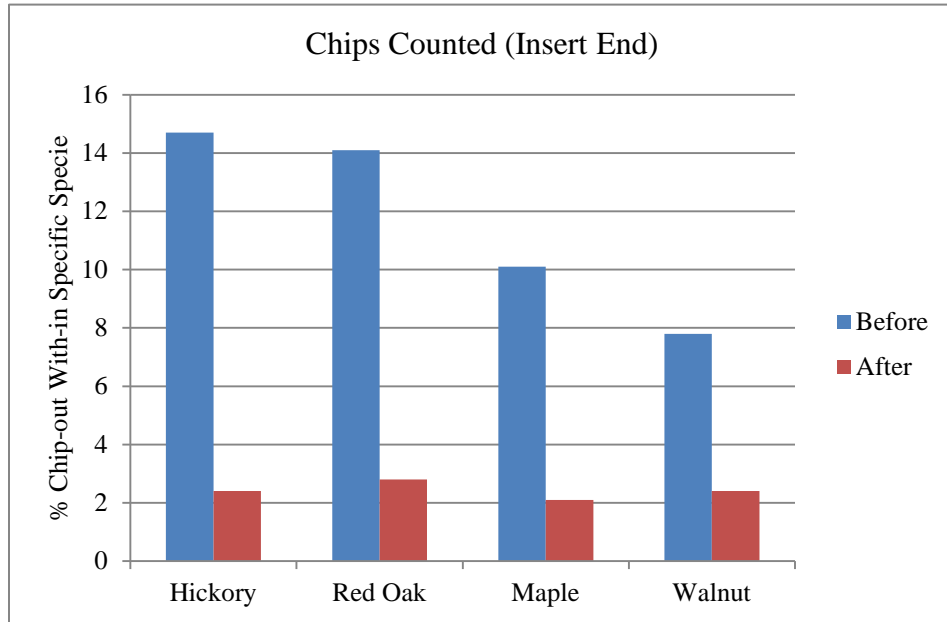
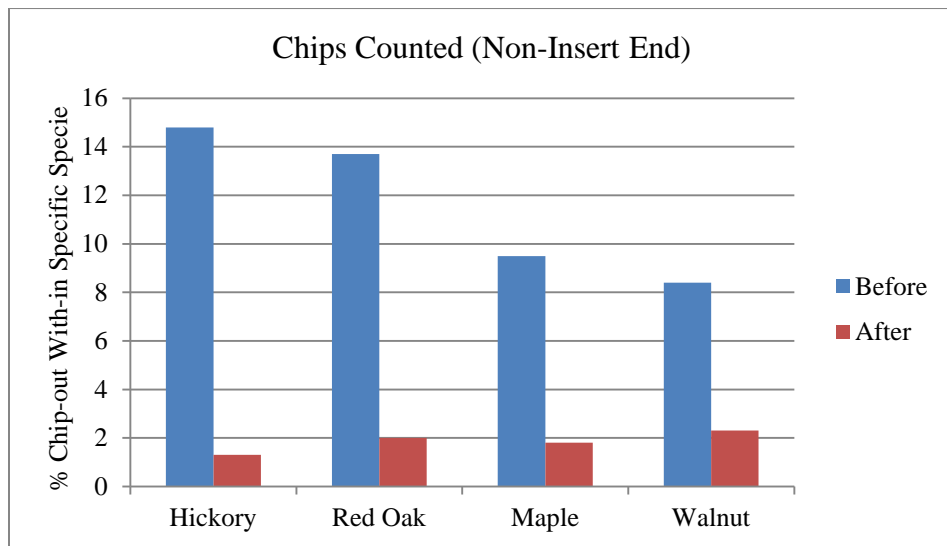
Non-Insert End					
	Hickory	Red Oak	Maple	Walnut	Average
Before	14.8%	13.7%	9.5%	8.4%	11.6%
After	1.3%	2.0%	1.8%	2.3%	1.9%
Overall Reduction in Chip-Out					16.4%

Table 7: Reduction in Chip-Out on Insert and Non-Insert End of Flooring

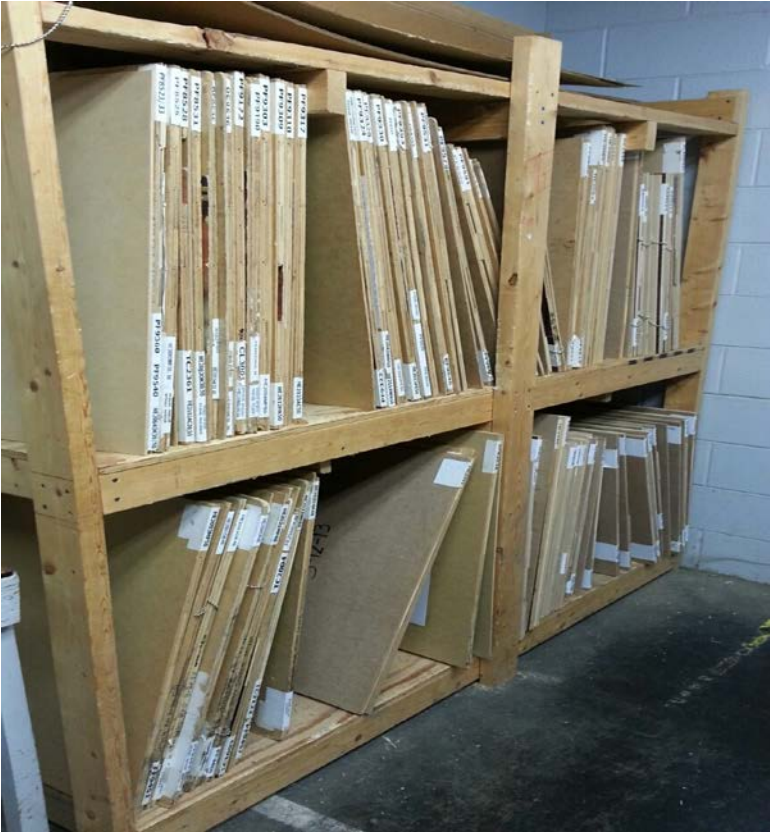
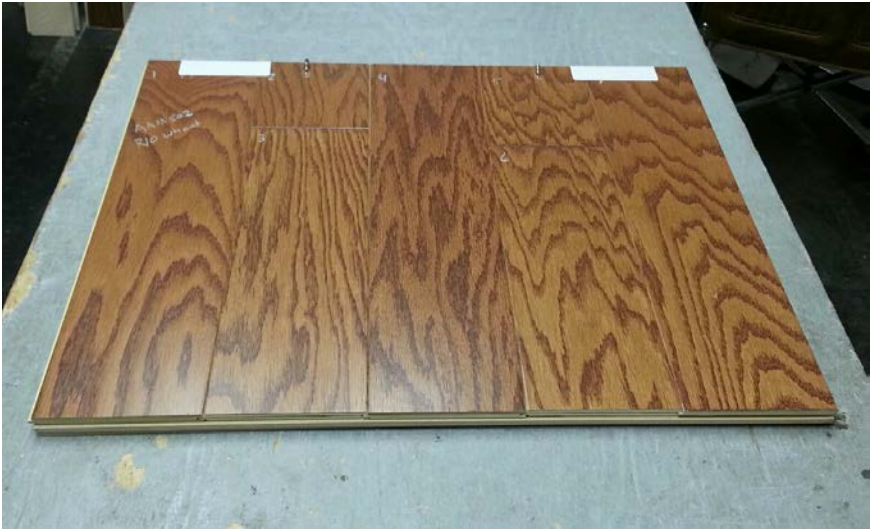
Pre-finish department line operators use experience, and trial and error to match flooring stain colors to established color board standards (Figure 8). Color board standards are built once product development teams approve new stain colors for customer products; material used for color board standards are pulled from the actual approved test runs. During the initial color set-up of a new product, detailed notes are kept as to what dyes are added to a base stain in order to achieve a specific color. Once a specific color is finalized, the detailed notes are filed in an electronic data base, as the stain recipe, for use in all future production runs for that particular product.

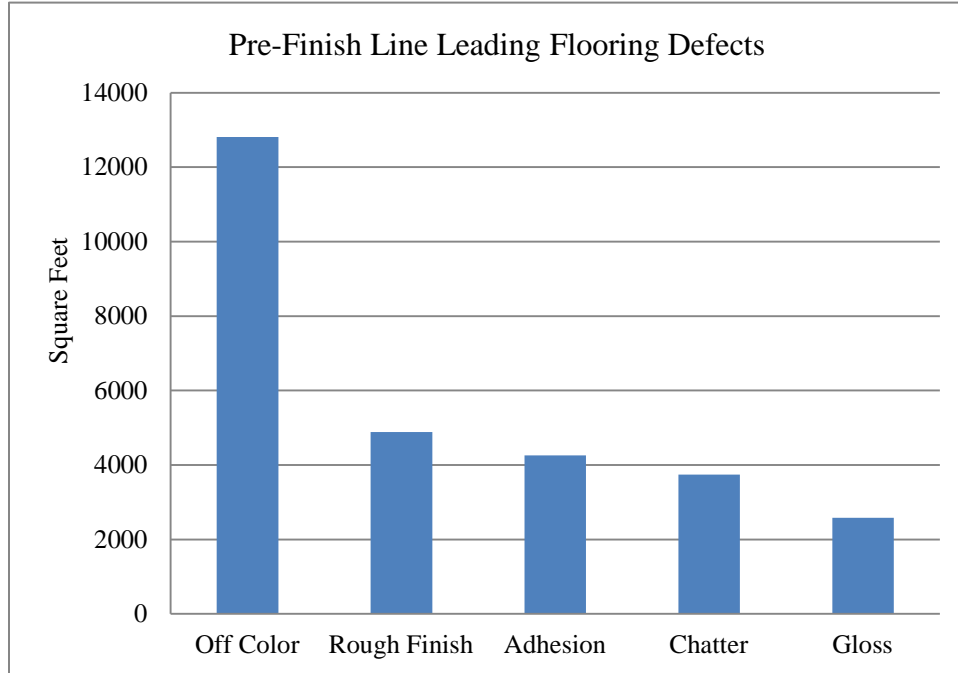
Table 8: Pre-Finish Line Top Five Defects Found During Quality Audits

Data gathered from months of quality audits is used for pareto analysis; and displayed in a pareto diagram. A pareto diagram is one of the seven basic quality tools used for process improvement projects. After plotting data, it is clearly visible that product off-color is an issue needing addressed (Table 8). Addressing this issue requires determining why product off-color is such an issue.

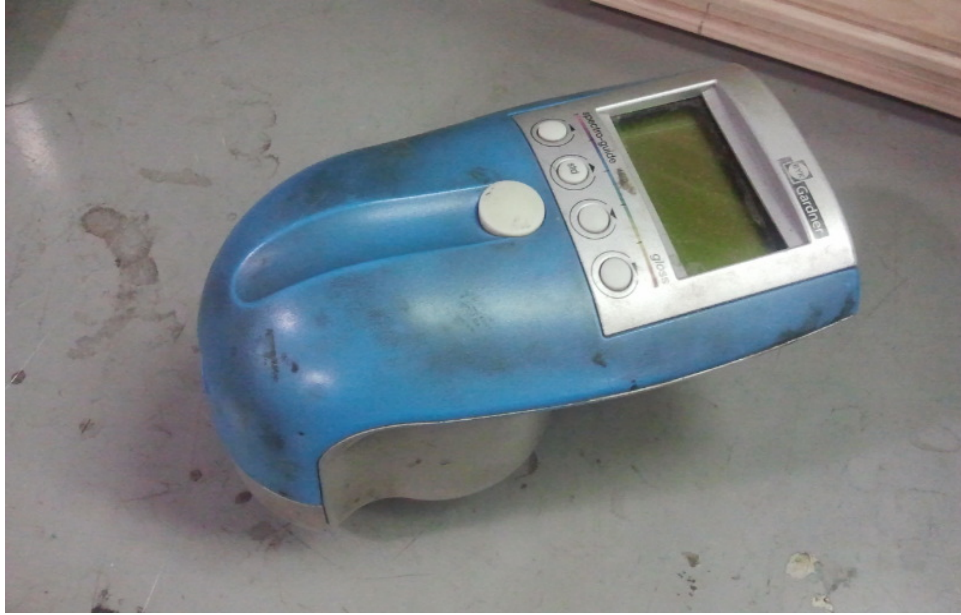
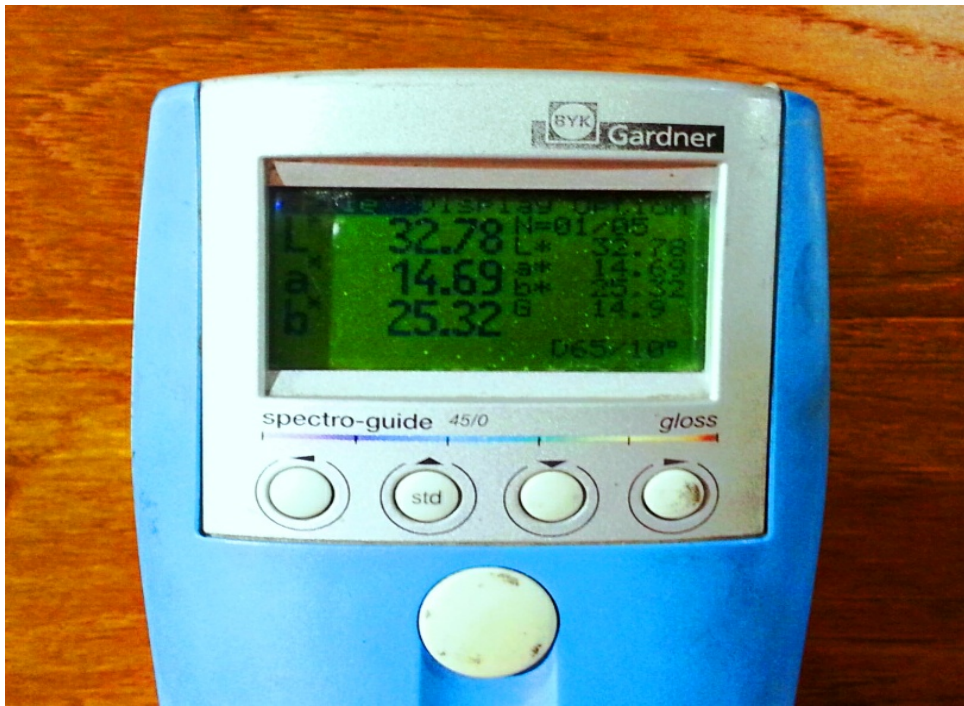
Although this thesis will not go into the inner workings of the Color Spectrophotometer, some basic information on it and the Hunter Color Scale is needed as these two items are used together to determine correctness of color match as well as determining needed color adjustments. The Spectro-Guide 45/0 measures the amount of light, in wavelengths, as it passes through a medium and displays the results in the form of numeric outputs.

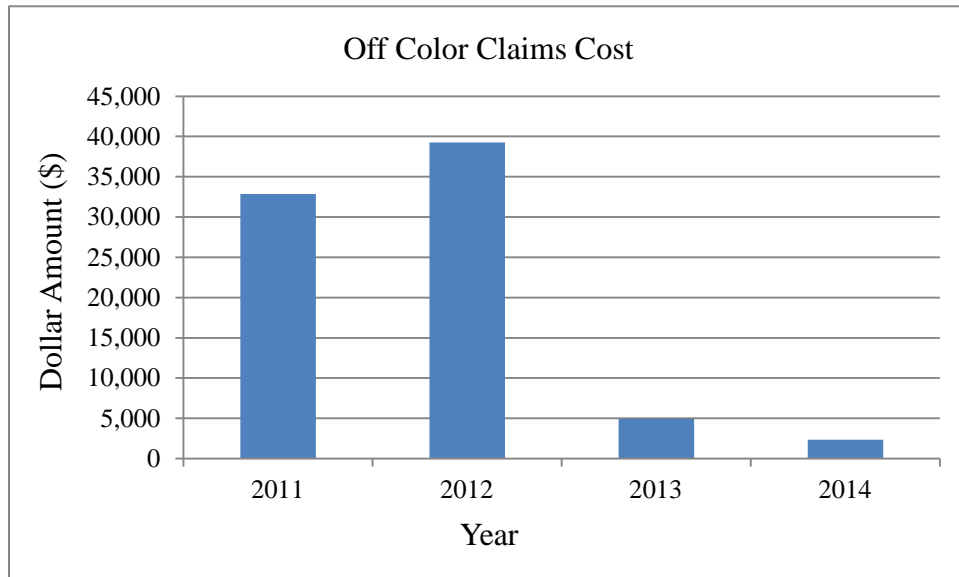
Prior to the off-color improvement project it was common practice for pre-finish line operators to start production runs when color-sets were close to matching the color standards visually, based on the operator's opinion. After implementing the use of the Color Spectrophotometer and an established process check list, production runs cannot proceed until color set-ups fall within a given range on the color standard. These process changes reduced off-color customer claims by an average of 10% between the years 2011-2012 and 2013-2014 as can be seen from Figure 24 below. This decrease represents a cost savings of \$13,928 annually.

Table 11: Off Color Improvement Project; Chart shows an Average Reduction in Claim Payouts of 10% Between the Years of 2011-2012 and 2013-2014

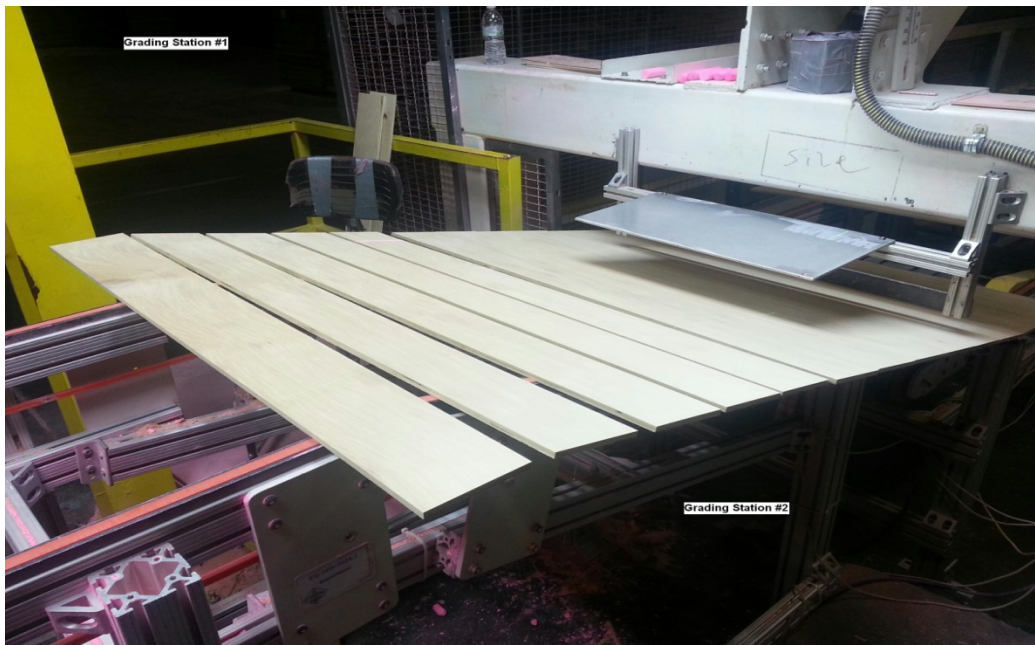
The third and final improvement project involves inconsistent product grading. In the EGD Department, there are three flooring grader positions (Figure 16 and 17), in grader position one and two graders are required to identify and mark, with chalk, defects and unwanted natural character in each piece of flooring that passes them.

Figure 16: EGD Grading Stations One and Two

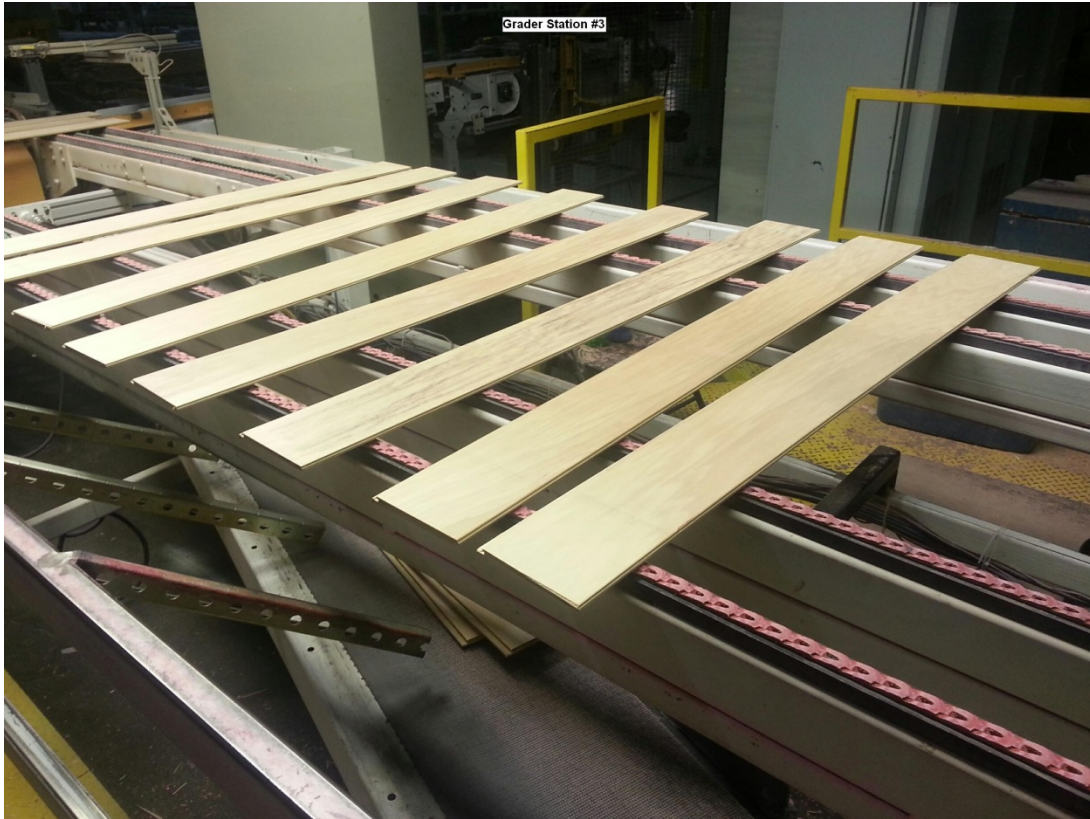
Figure 17: Grading Station Three

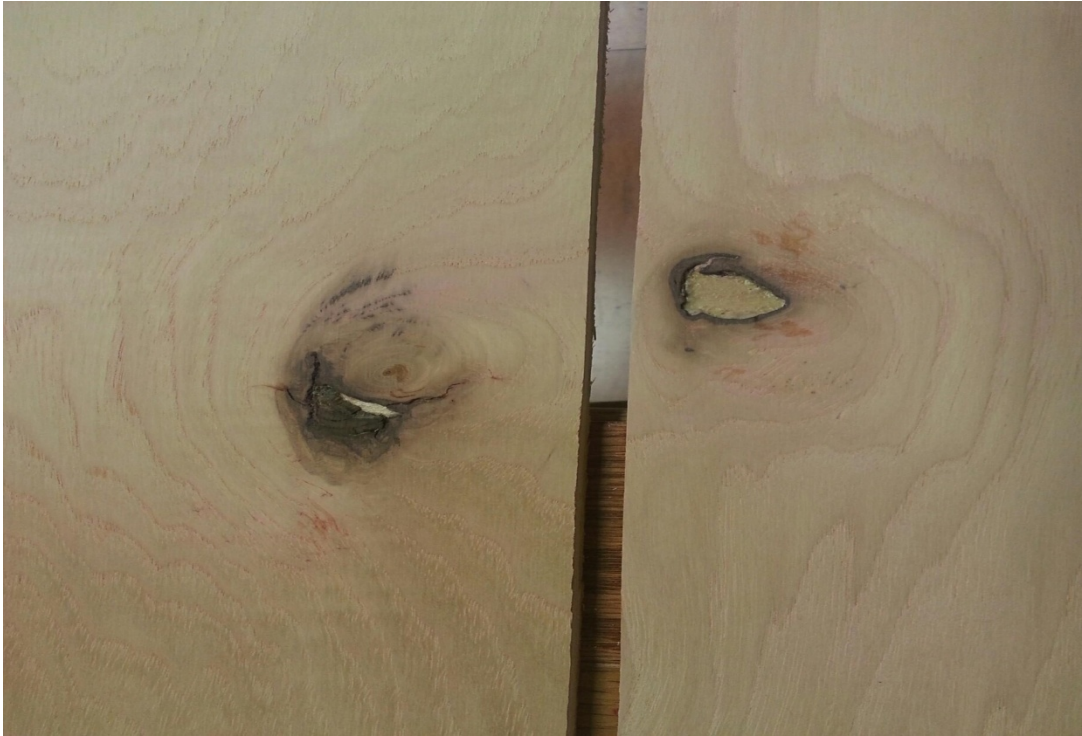
Figure18: Knot Holes in the Face

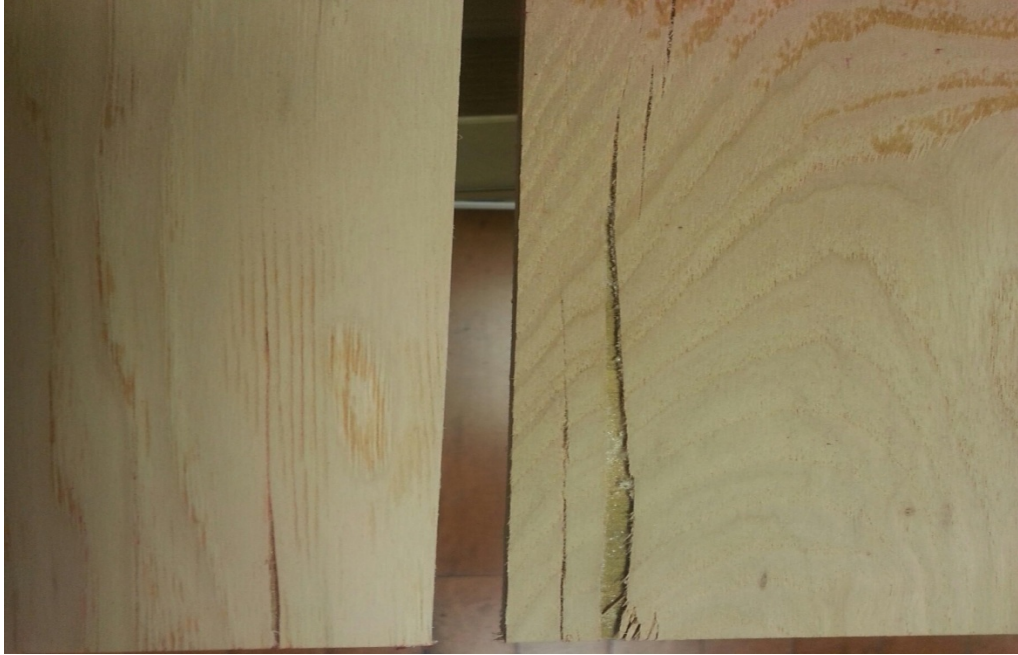
Figure 19: Splits in the Face

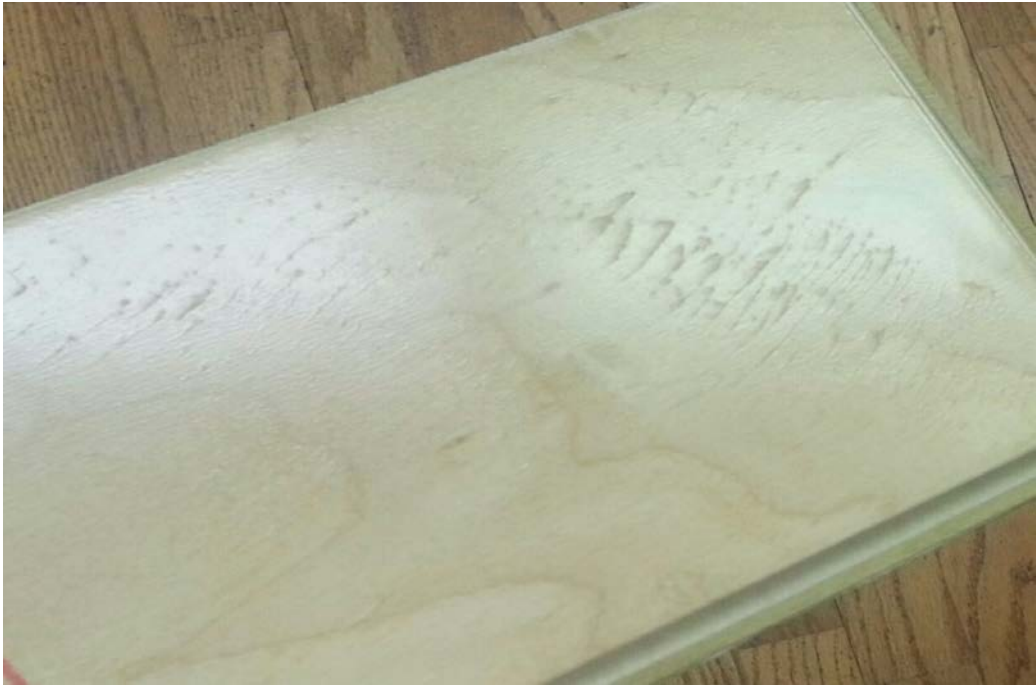
Figure 20: Raised Grain in the Face

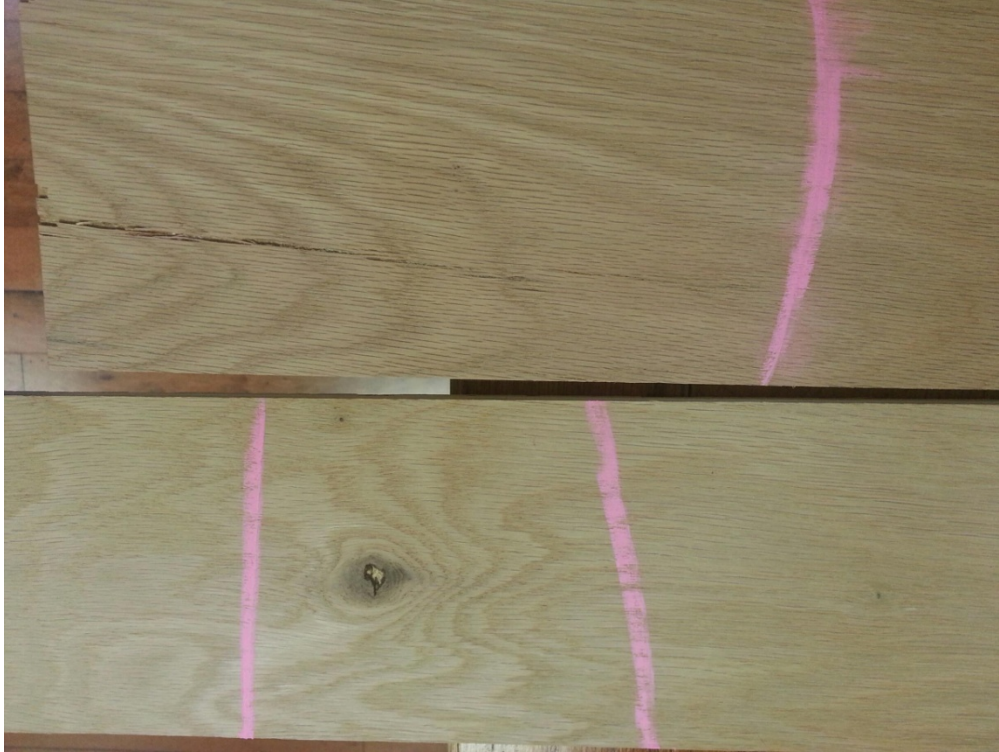
Figure 21: Chalk Mark Location too far Away from the Actual Defect

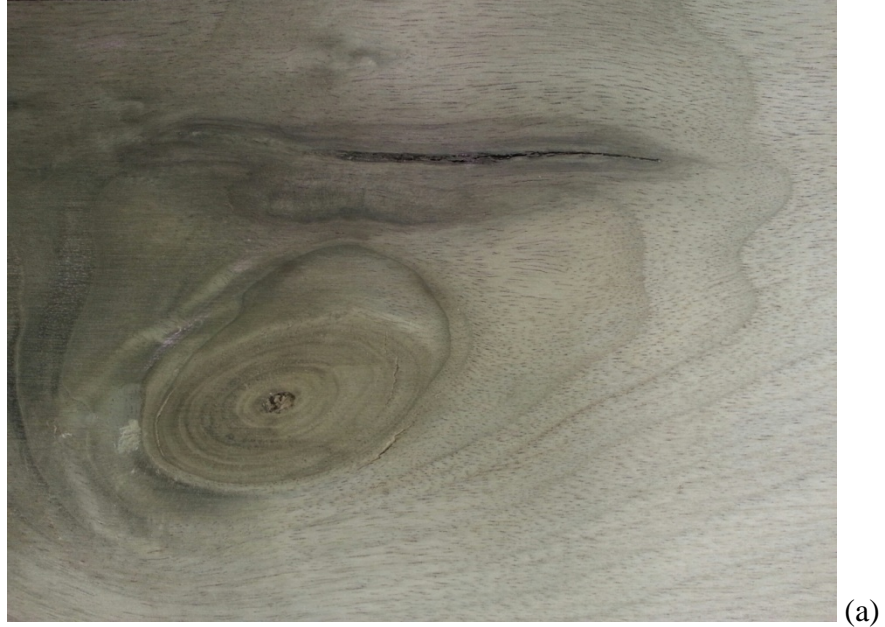
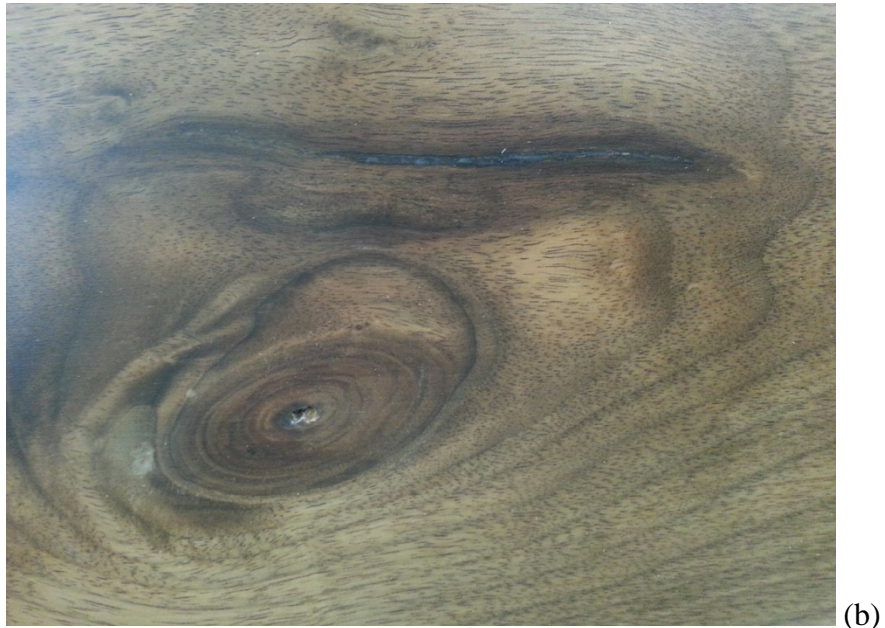
Figures 22 through 24 show common examples of defects that once thought to be too large to let go, and marked to be defecting out, actually meet the minimum pre-finish grading specifications. In Figures 22 through 24 the upper photo was taken prior to the finishing process to show the defects as the graders see them, while the lower photo was taken after the finishing process. These visual samples also serve to help the graders relate visual defects with numeric size limits.

Figure 22: (a) Unfinished Elongated and Circular Defect; (b) Elongated Defect Filled During the Finish Process where as the Circular Defect Did Not Fill

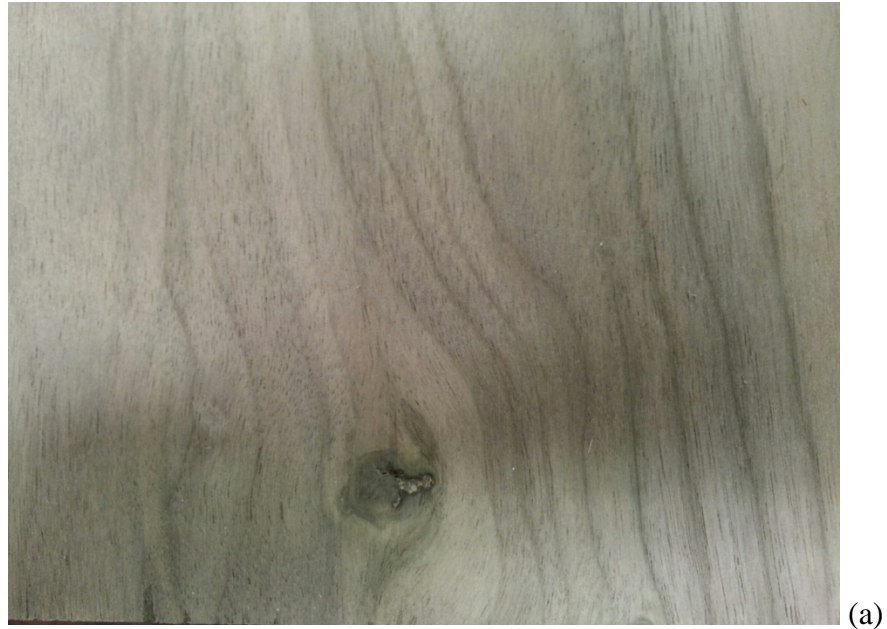
Figure 23:(a) Unfinished Open Knot Defect;(b) Open Knot Defect Filled During the Finish Process

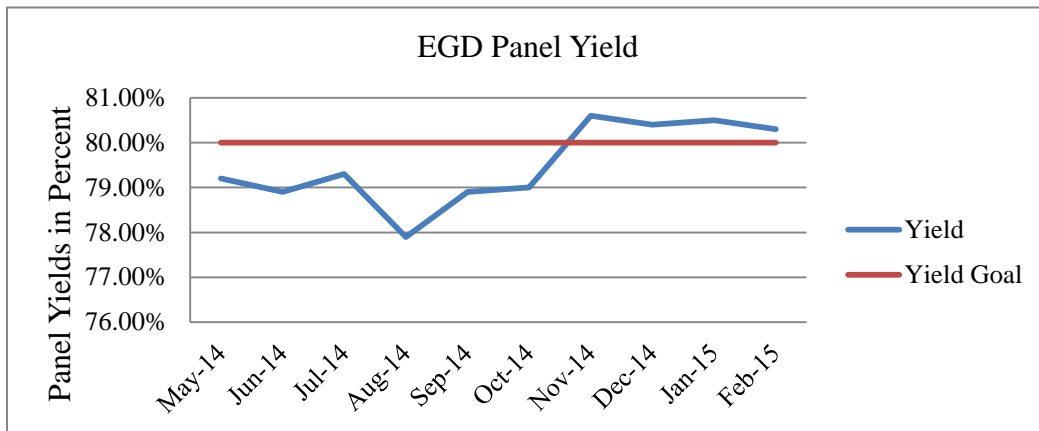
In the past, product grading or grader training was not looked at with any serious focus so historical data for EGD production yields are considered to be a good baseline for past grader performance. At the completion of the inconsistent grading project, data collected over a relatively short period of time showed an immediate improvement in EGD panel yield. Overall panel yield increased on average by 1.7% as shown in Table 13 below. This increase in panel yield represents a \$167,500 dollar savings annually for QEP.

Table 13: EGD Panel Yield Increase of 1.7%
