### Slope Stability Risk Assessment in Urban Development, Eastern Tennessee Hillslope

# Slope Stability Risk Assessment in Urban Development

Noah C. Hickerson, Arpita Nandi, David Jennings  
 East Tennessee State University, Department of Geosciences

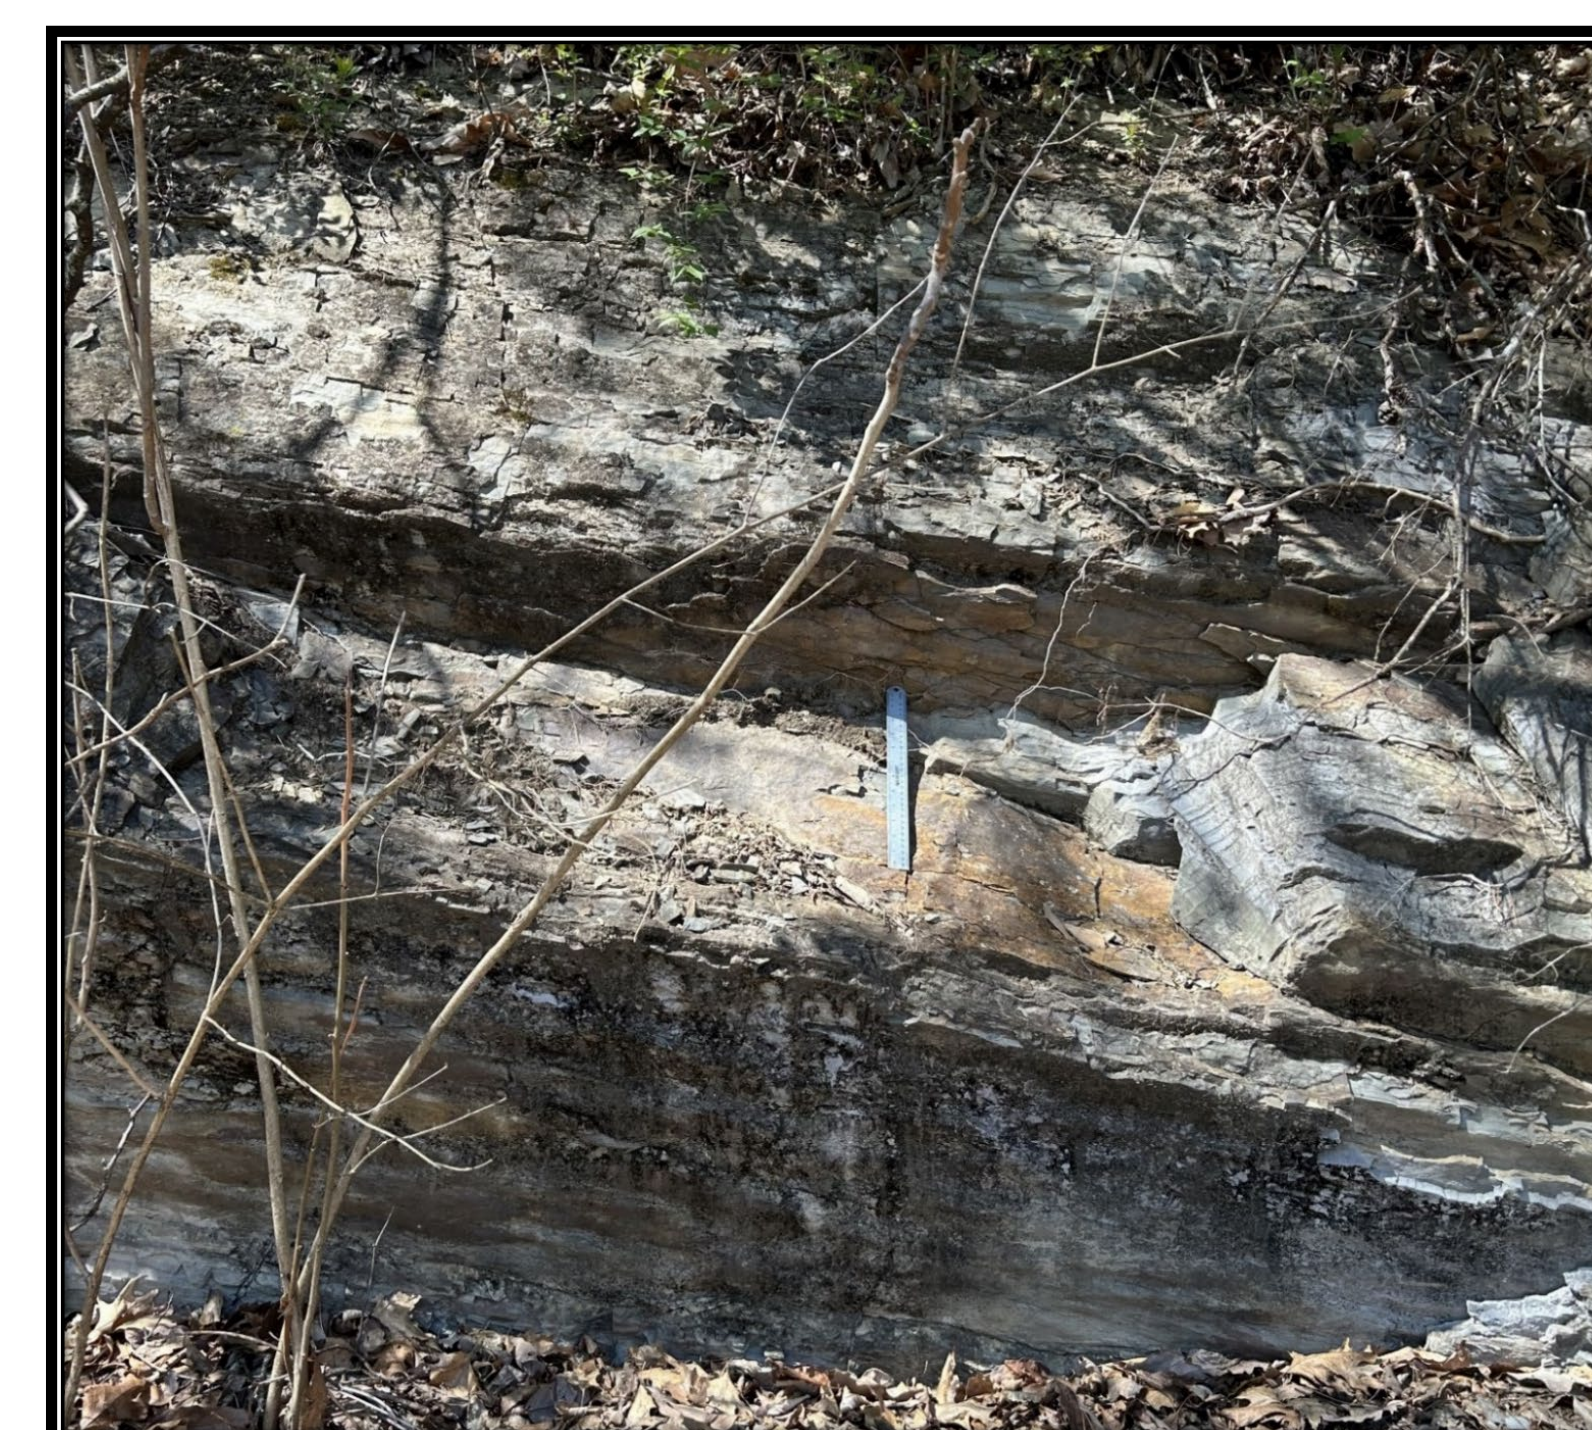
Figure 3: A picture of Sevier Shale outcrop showing the bedding of the shale.

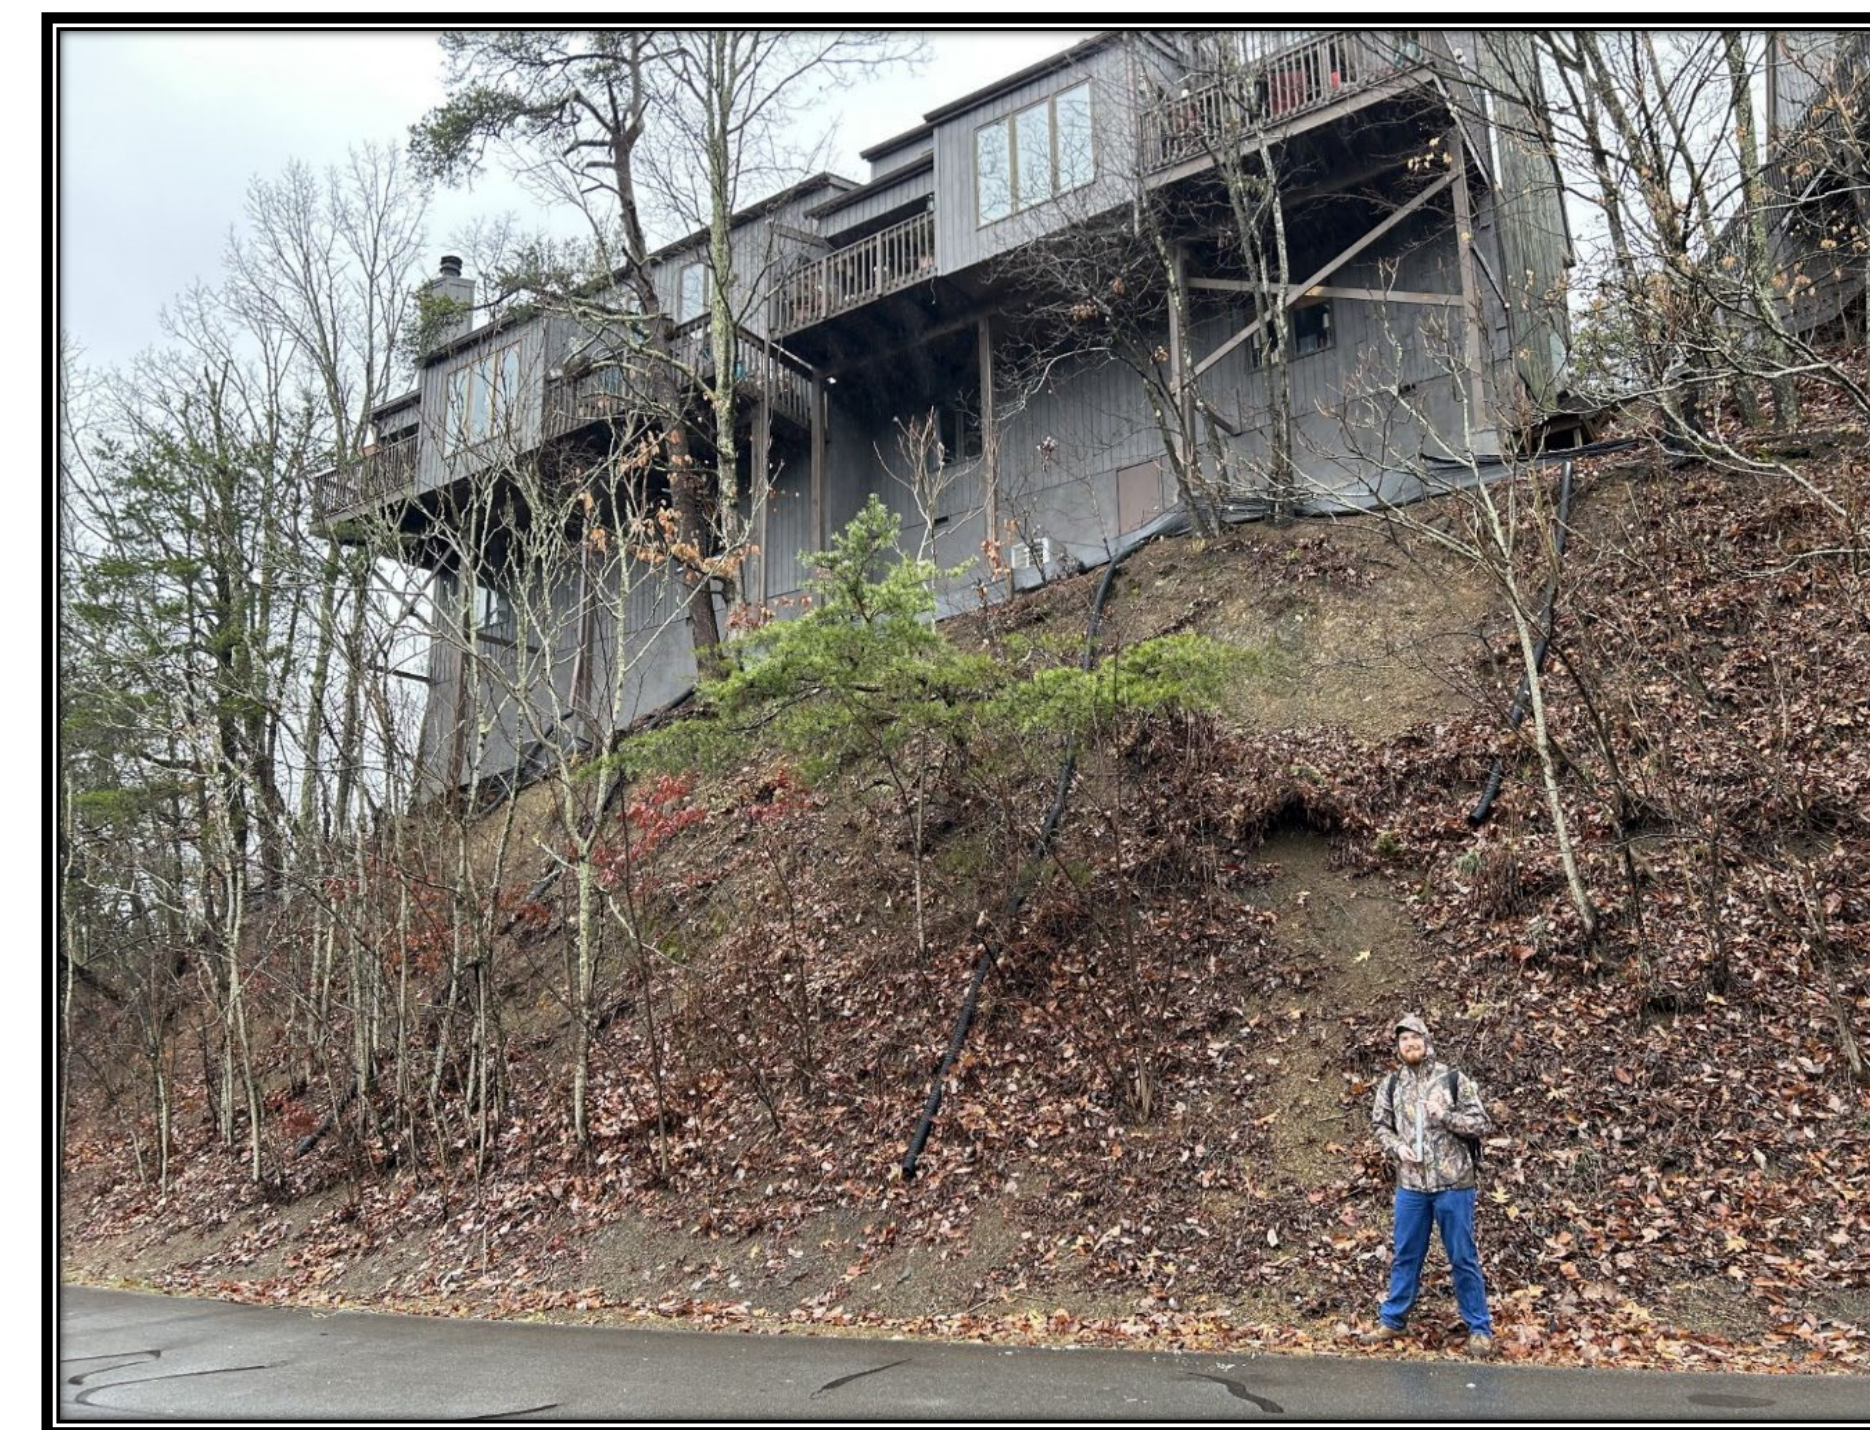
Figure 4: A picture of a steep slope behind some of the houses, the slope here was 51°.

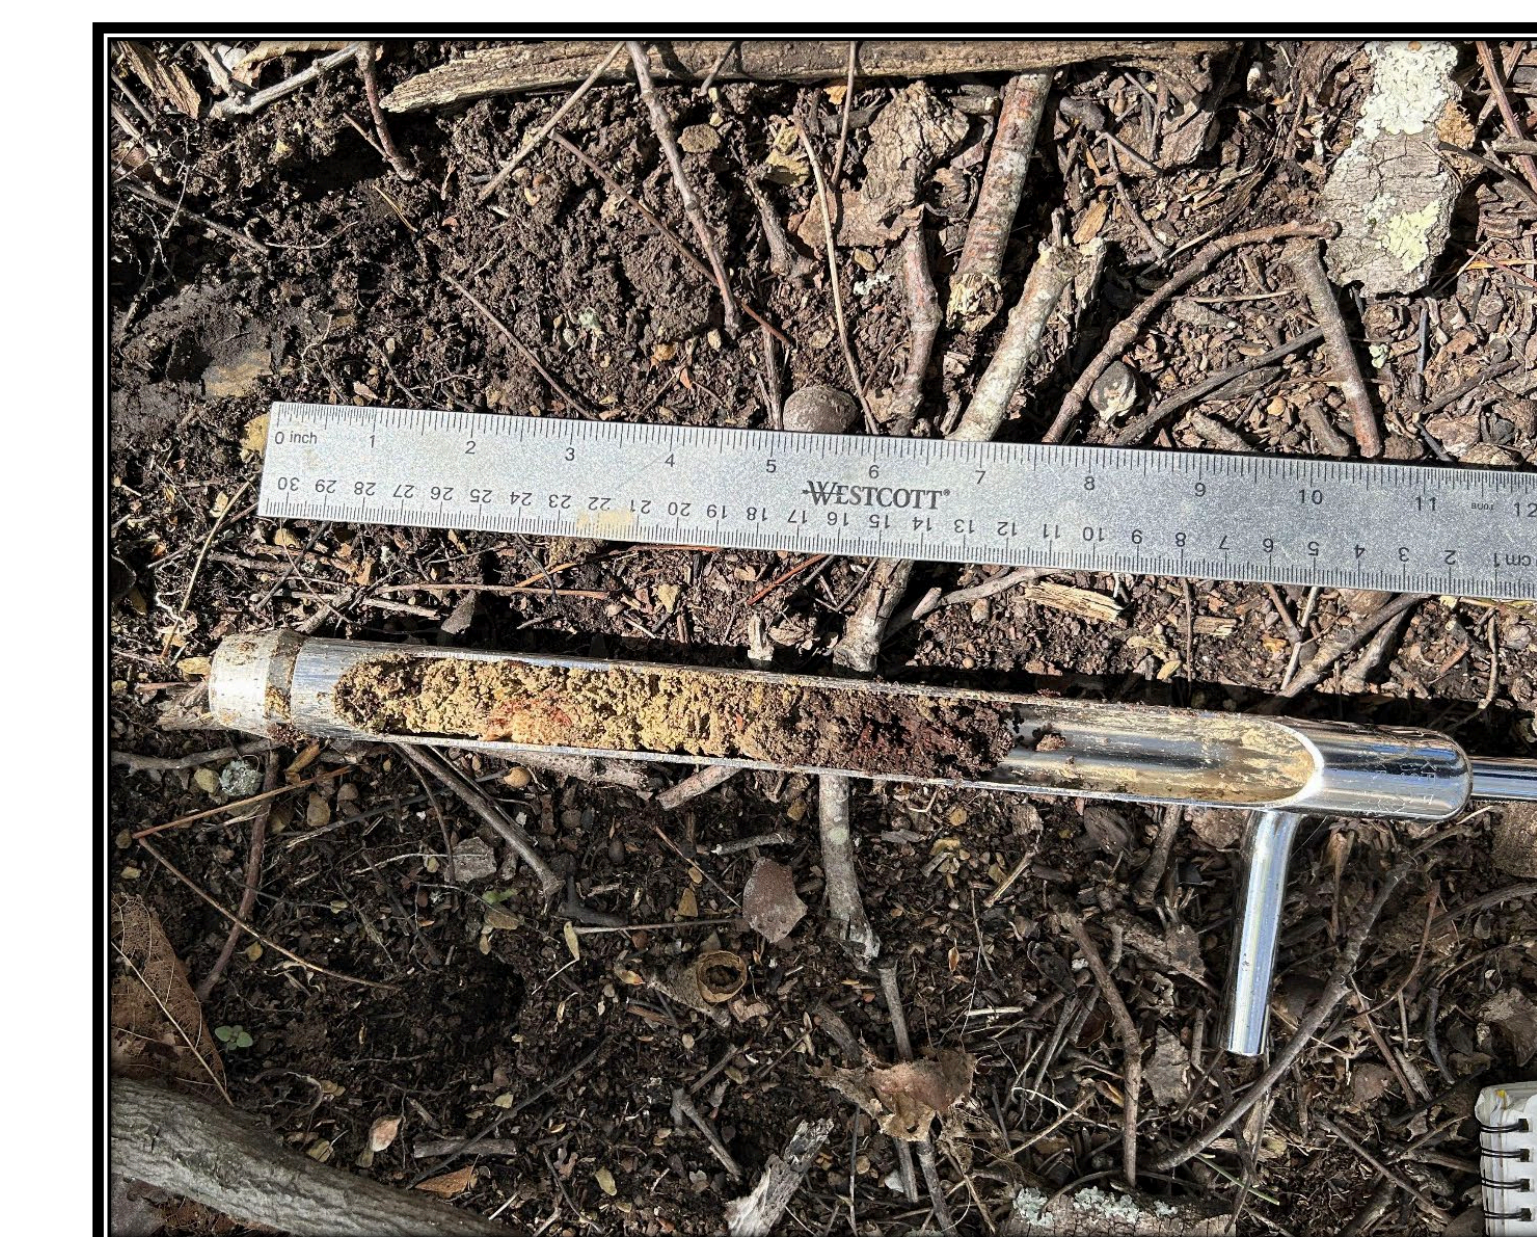
Figure 7: A soil sample, this was one of the more complete soil samples within the study area as there was so much fractured shale in the soil it was often difficult to obtain a core.

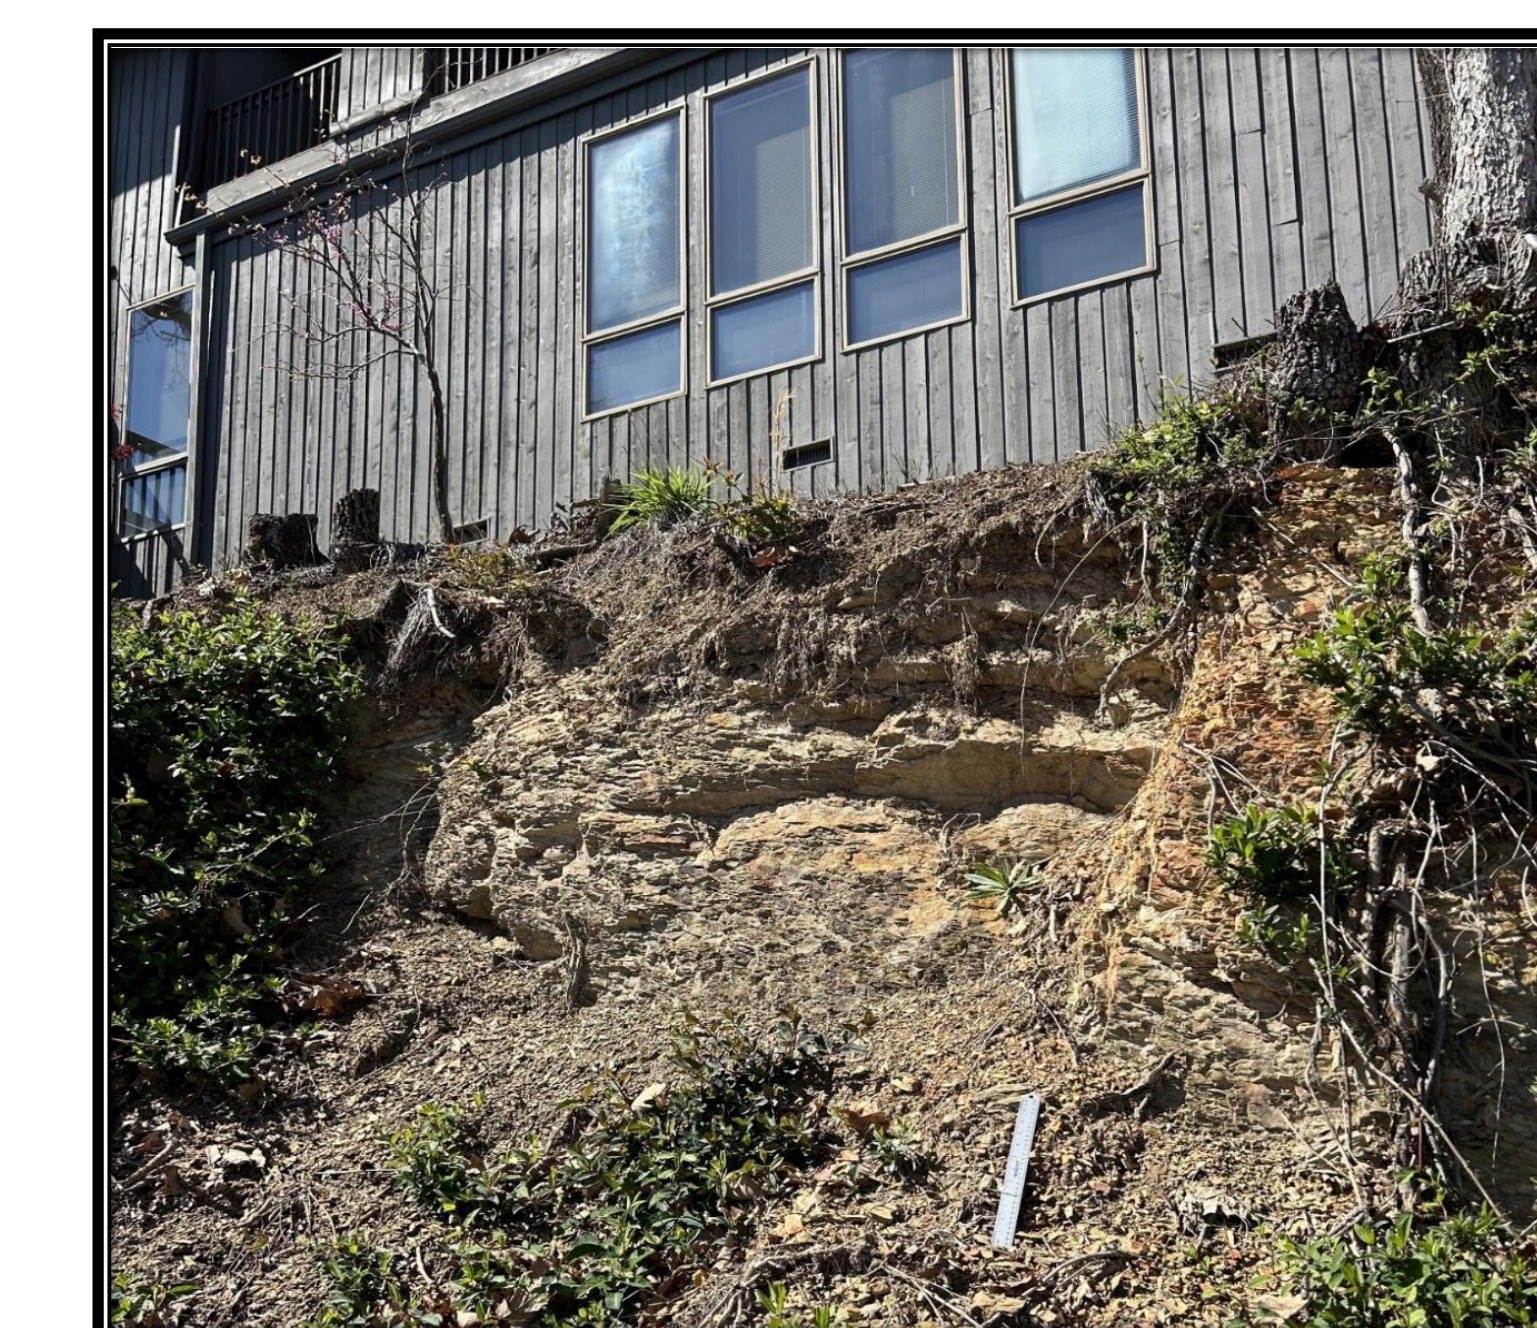
Figure 6: A steep slope showing outcrop of Sevier Shale, this area has had slope failures as recent as 2022.
