Analysis and Risk Estimation of High Priority Unstable Rock Slopes in Great Smoky Mountains National Park, Tennessee and North Carolina

A thesis

Master of Science in Geosciences, Geospatial Analysis

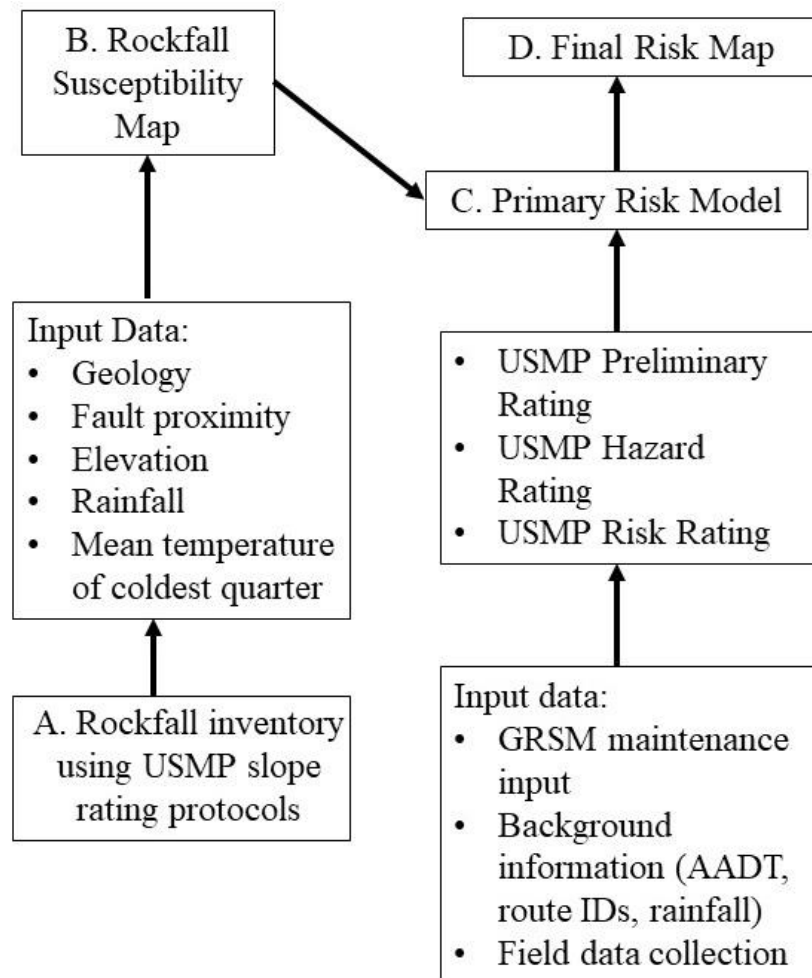
Figure 0.6. Flowchart of the research

A detailed flowchart (Figure 2.6) describes the methods to accomplish the four objectives of the study: (1) Create an inventory of unstable slopes, (2) Produce a susceptibility model, (3) Prepare a preliminary roadway risk map using USMP scores, (4) Combined the susceptibility model and risk map to create a final risk map for GRSM.

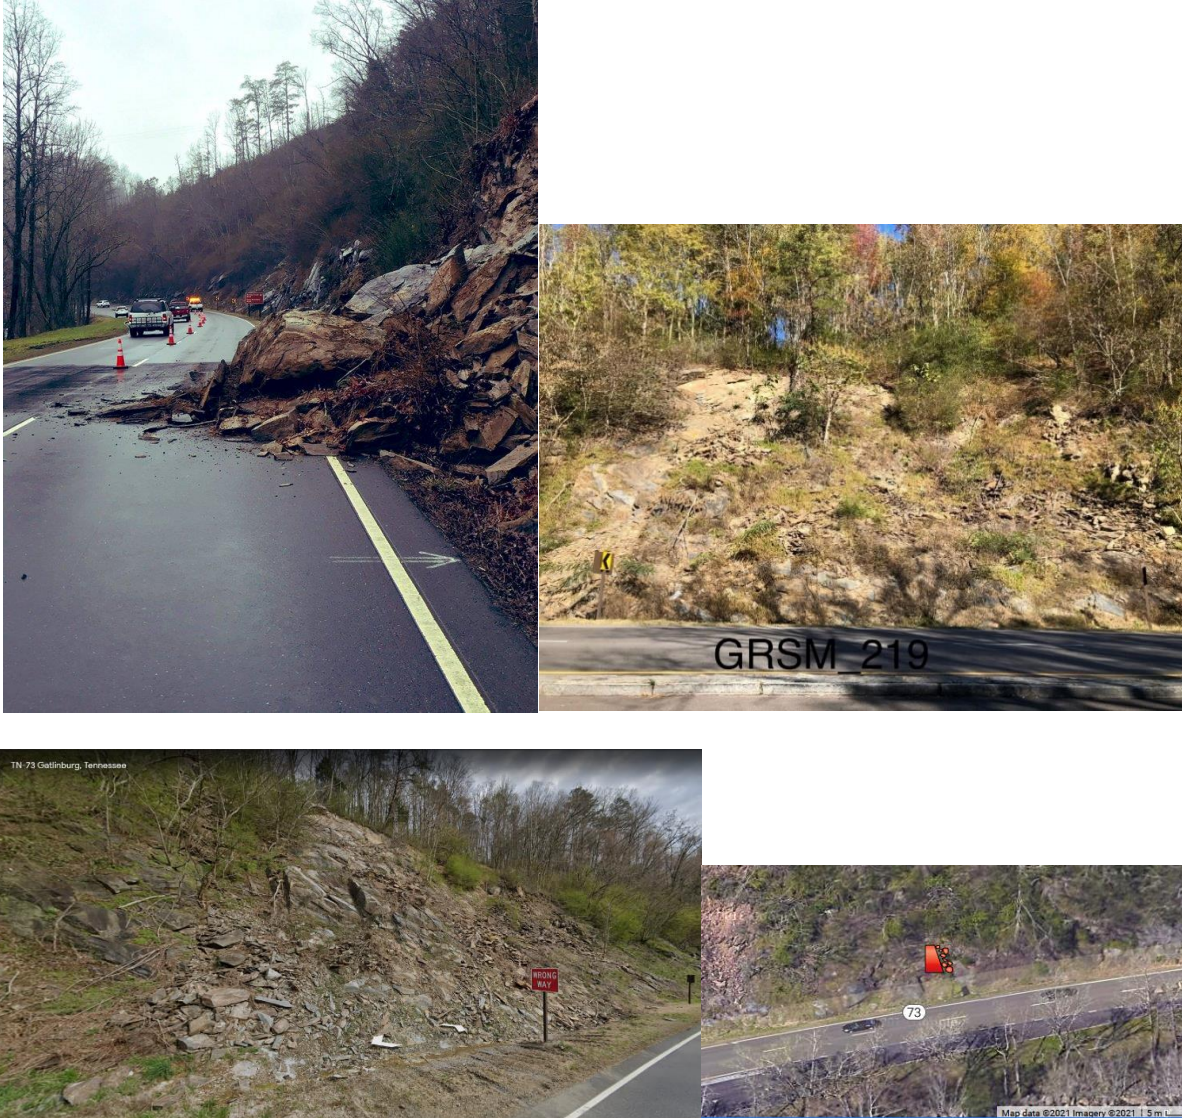
Figure 0.1. Top right: GRSM_219: the slope suspected to be the one that failed on February 12, 2021 on the Gatlinburg Spur. This slope received a poor rating (554) and was noted that previous wedge failures had occurred here. Bottom left: Google Earth image of GRSM_219 before failure. Bottom right: GRSM_219 shown on the interactive USMP database.

The most recent slope failure occurred on February 12, 2021, on the southbound lanes of Gatlinburg Spur and closed one lane of traffic. Not much information was provided, other than a stability investigation was ongoing and could close both lanes if the slope were deemed still unstable (WBIR News 2021). Based on the single photo from the news article (Figure 3.1), it is assumed this is slope GRSM_219. If correct, this slope received a ‘poor’ rating (554) and was noted that this was the site of a previous wedge failure. The rockfall was likely caused by heavy rainfall and possibly freeze/thaw conditions from the fluctuating weather.

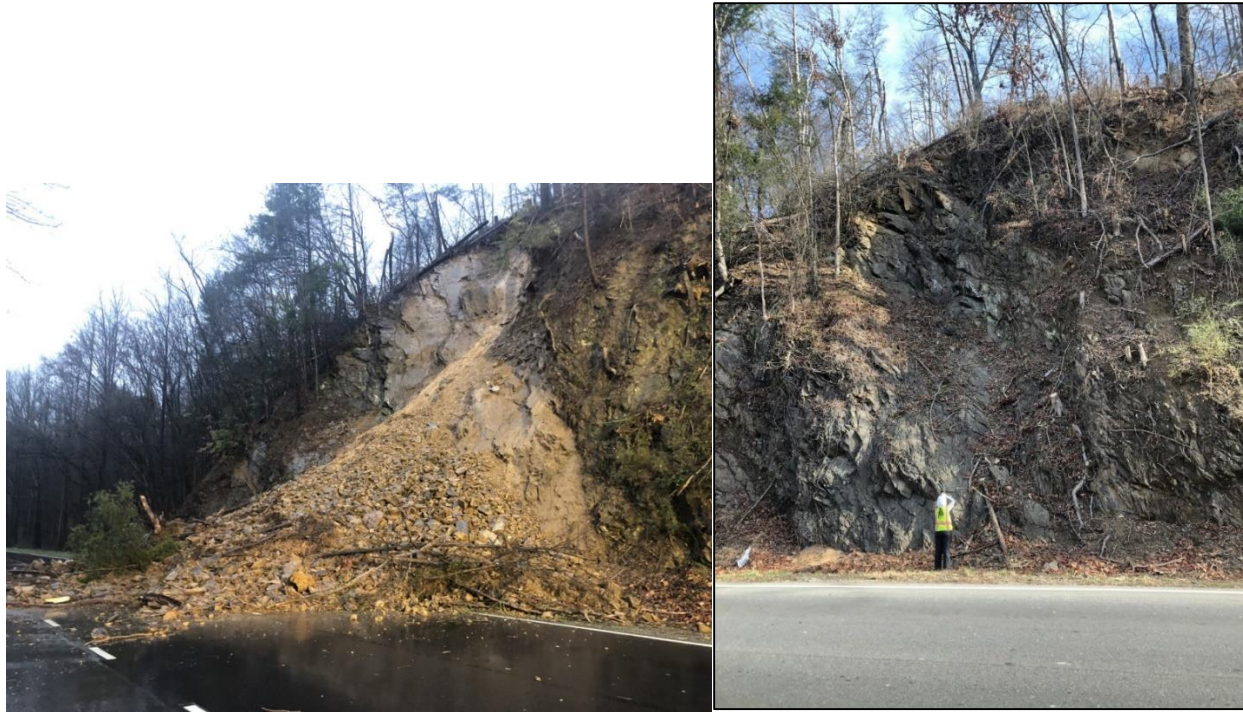
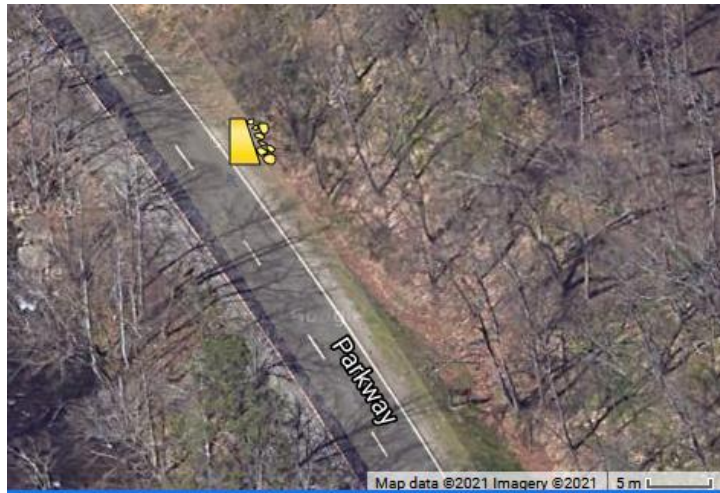
Figure 0.2. Left: Landslide that occurred on February 11, 2020 on Gatlinburg Spur in Great Smoky Mountains National Park. It was estimated by GRSM officials it would take 45 dump trucks to remove the estimated 500 cubic yards of material from the road. This slide did block both northbound lanes of the Spur. Photo: WJHL News (2020). Right: Samantha Farmer (researcher) in the process of rating GRSM_233, the mentioned above slope that failed. GRSM_233 received

a 'fair' rating, and likely failed due to heavy precipitation. Photo credit: Thomas O'Shea (ETSU).
Bottom: GRSM_233 shown on USMP interactive database.

Another, recent recorded slope failure occurred on February 11, 2020 after the park experienced heavy rains. The slope failure happened in the northbound lanes of the Gatlinburg Spur, the busiest road in GRSM, and closed it for several hours. It was estimated that the failure was approximately 500 cubic yards of debris in a 100-foot-long and 70-foot-tall area (WJHL News 2020). According to WJHL News (2020), GRSM officials expected 45 dump truck loads would be required to remove the material. It should be noted that this slope was rated (GRSM_233) and received a 'fair' rating (386) (Figure 3.2). Traffic was able to be detoured to small side roads.

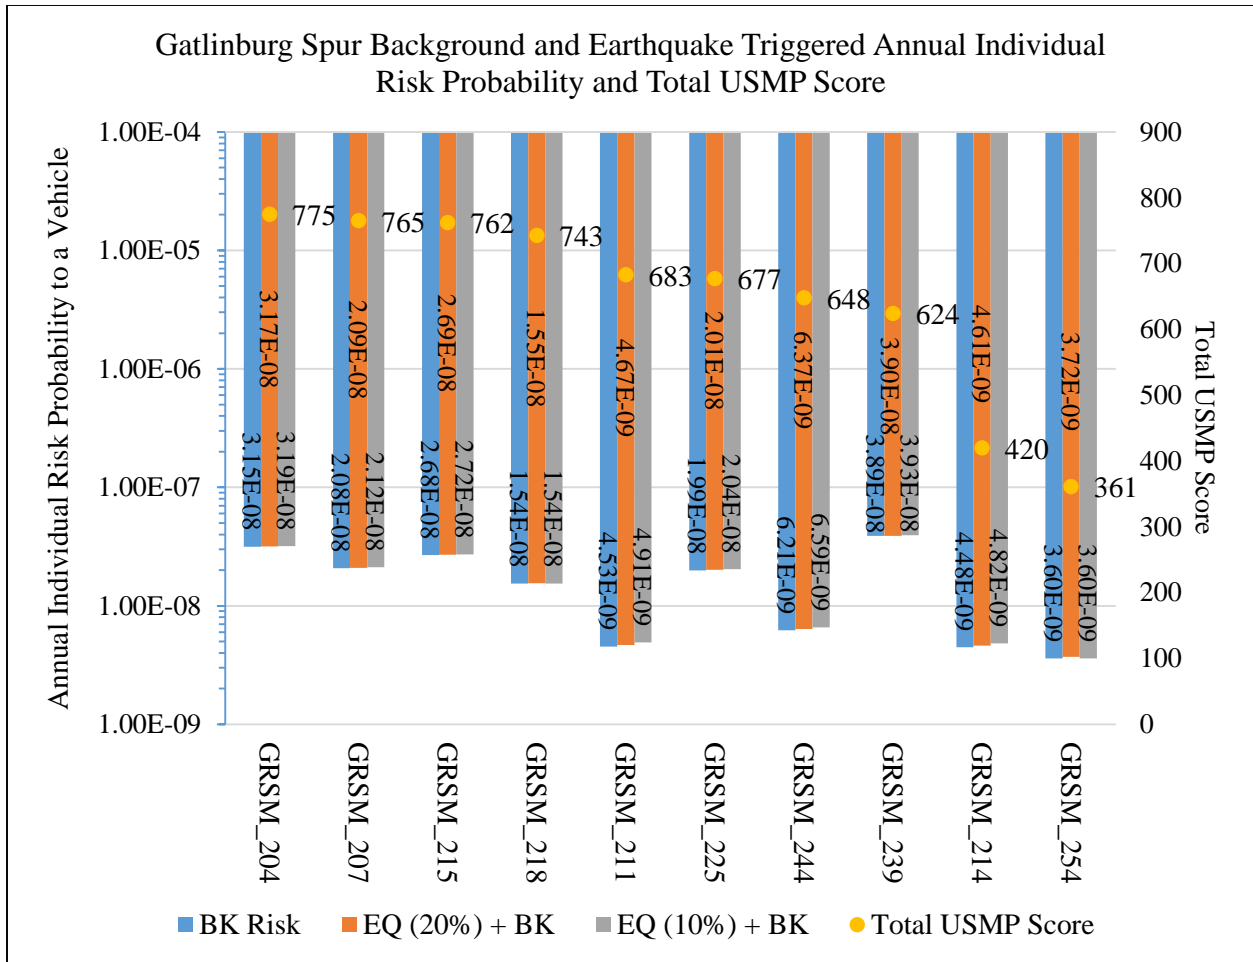
Figure 0.8. Gatlinburg Spur earthquake and non-earthquake triggered annual individual risk probability coupled with the corresponding slope’s total USMP score. The blue bar represents background risk, orange is earthquake risk when $g = 10\%$, grey is earthquake risk when $g = 20\%$, and the yellow point represents total score.

Based on the USMP QRA protocols for each of the slopes on the corridors, background risk and earthquake risks were plotted together in conjunction with total score to provide a better understanding of the risk of the corridor (Figures 3.5-3.7). A graph was created for each roadway to provide visual context on annual individual risk, as well as the impact of background risk in addition to earthquake risk when the peak ground acceleration is 10% and 20% at a specific slope.

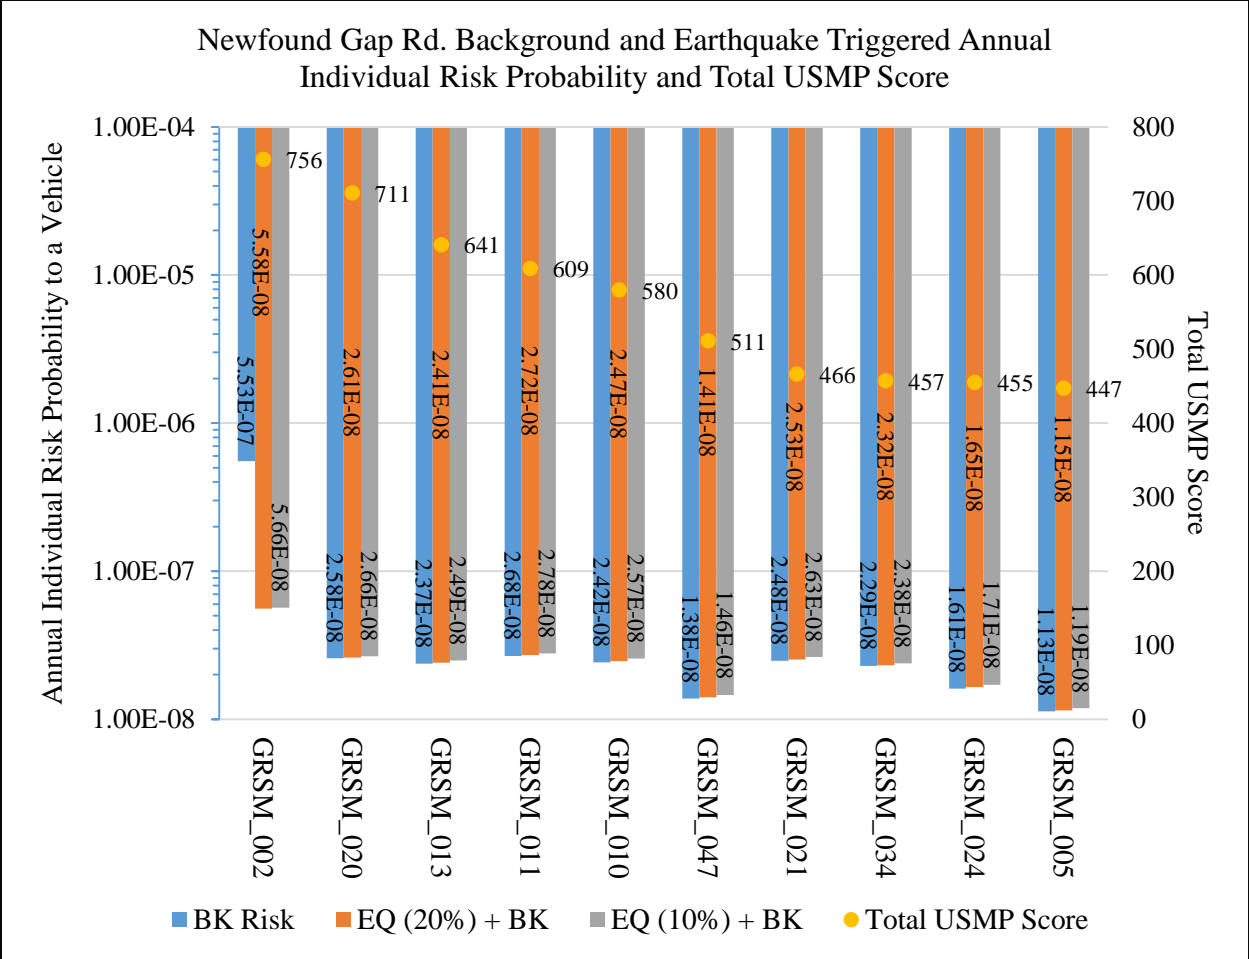
Figure 0.9. Newfound Gap Rd. earthquake and non-earthquake triggered annual individual risk probability coupled with the corresponding slope’s total USMP score. The blue bar represents background risk, orange is earthquake risk when $g = 10\%$, grey is earthquake risk when $g = 20\%$, and the yellow point represents total score.

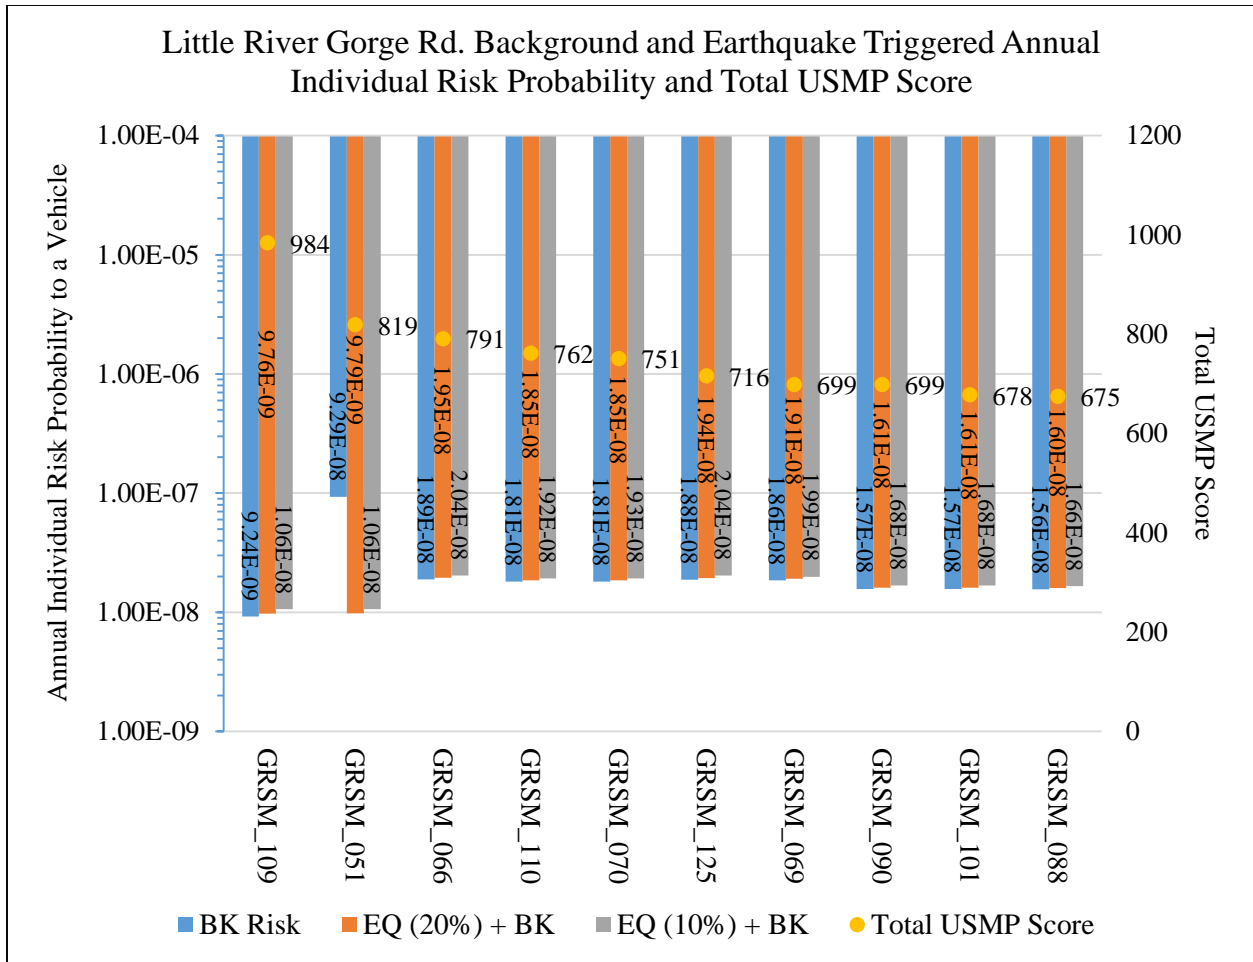
Figure 0.10. Little River Gorge Rd. earthquake and non-earthquake triggered annual individual risk probability coupled with the corresponding slope’s total USMP score. The blue bar represents background risk, orange is earthquake risk when $g = 10\%$, grey is earthquake risk when $g = 20\%$, and the yellow point represents total score.

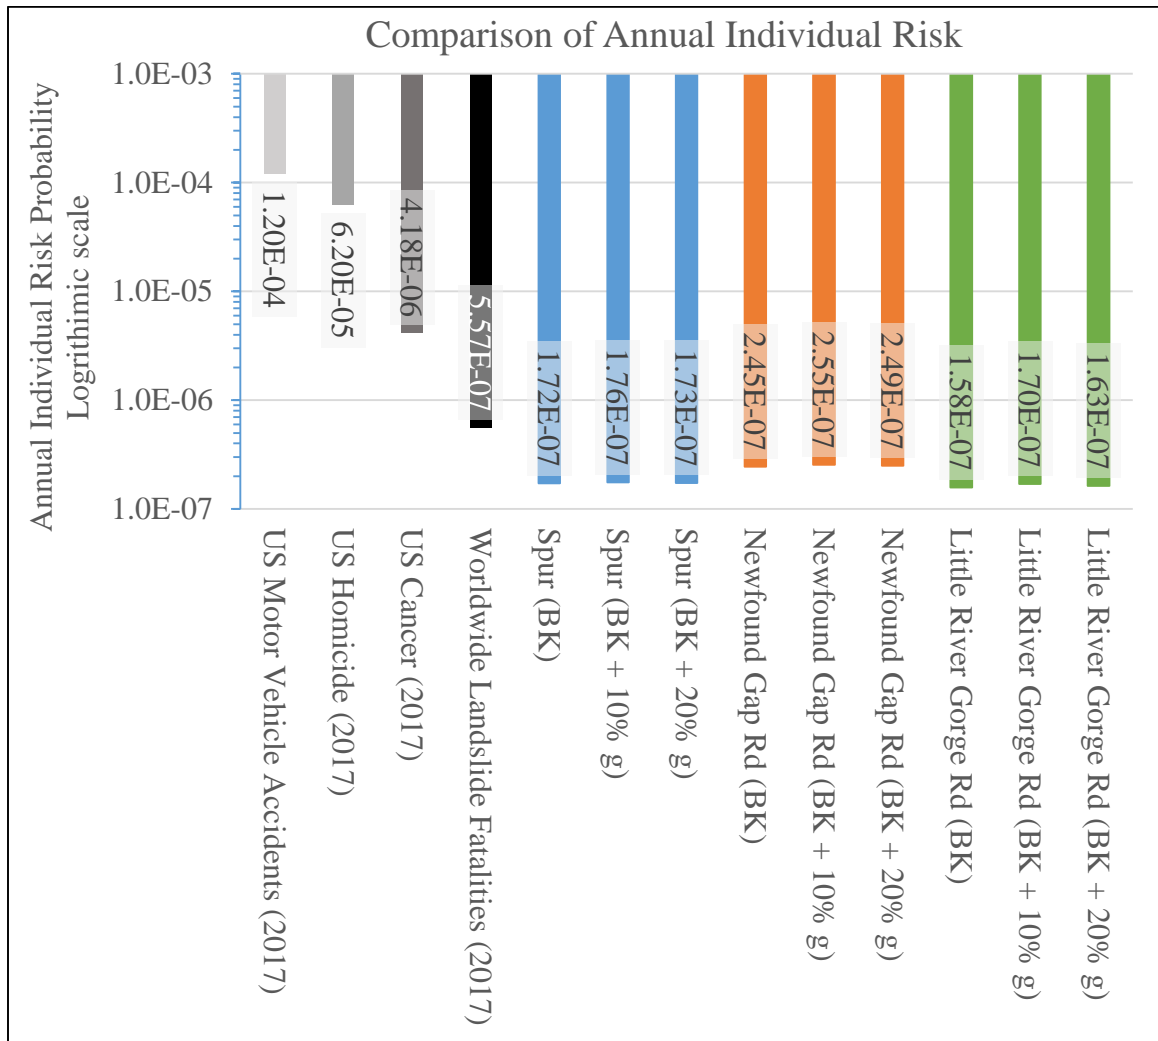
Figure 0.12.GRSM Gatlinburg Spur, Newfound Gap Rd, and Little River Gorge Rd annual individual risk probabilities being compared to other well-known societal risks to allow non-specialists a better understanding of the risk.

Sum of BK risk, EQ risk 0.103, and EQ risk 0.203 for each of the three corridors were recorded and compared to other well-known societal risks, like cancer, homicide, and vehicle motor accident fatalities (Figure 3.9). This allows non-specialists, like maintenance staff, to gain a better visual understanding of the annual risk of the three most traveled corridors.

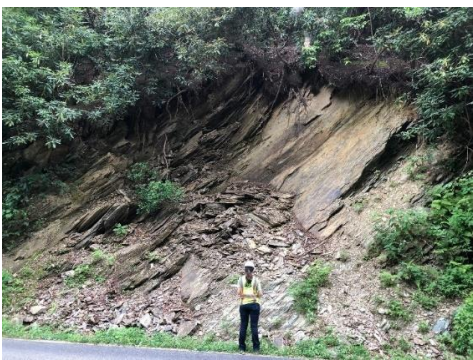
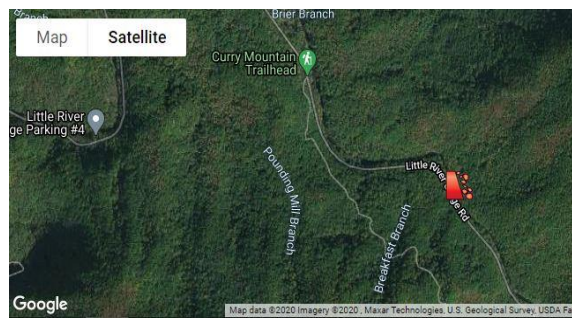
Figure 0.14. GRSM_051 located on Little River Gorge Rd is an ongoing wedge failure that is cleaned up annually. The red box indicates where this slope is in relation to the rest of the USMP inventory. Rock debris is continuously cleaned up and deposited on the opposite side of the road. Bottom Left photo credit: Thomas O’Shea, ETSU.

Little River Gorge Rd. (0014) is a major artery to GRSM and does not have any rockfall hazard warning signs. There is an active, ongoing wedge failure (GRSM_051 (Figure 3.11)) where the addition of a rockfall hazard warning sign would be extremely beneficial. There are clusters of highly rated unstable slopes along Little River Gorge Rd. where a hazard warning sign would also be beneficial (GRSM_068 to GRSM_073 and GRSM_086 to GRSM_090). These clusters are especially significant as comments were made at each slope indicating evidence of rock debris hitting the road (impact marks), and evidence of previous rockfall (GRSM_090). Knowledge of previous slope failure events would assist in pinpointing a location for an additional rockfall hazard warning sign. Potential rockfall hazard warning sign locations should be near GRSM_051 (Figure 3.11) on Little River Gorge Rd which is an active wedge failure, and GRSM_013 (Figure 3.12) on Newfound Gap Rd which is near a popular overlook area and had recent wedge failure. A more detailed study should be conducted to prioritize rockfall signs for more unstable slopes that have a history of frequent rockfall events that impact the road.

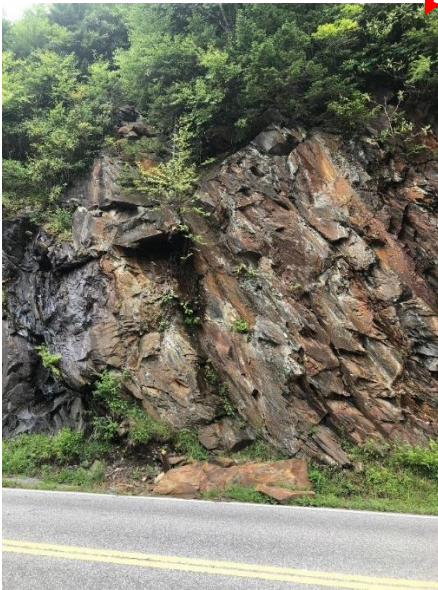
Figure 0.15. GRSM_013 on Newfound Gap Rd, located near Morton Overlook, a popular tourist spot. A 1.2m (4ft) rock can be seen in the ditch, that almost hit the road. Had this rock hit the road, traffic would have had to be diverted or closed as this is the only way up and down the mountain until Clingmans Dome. The red box indicates where the GRSM_013 is located. Bottom Left photo credit: Thomas O’Shea, ETSU.

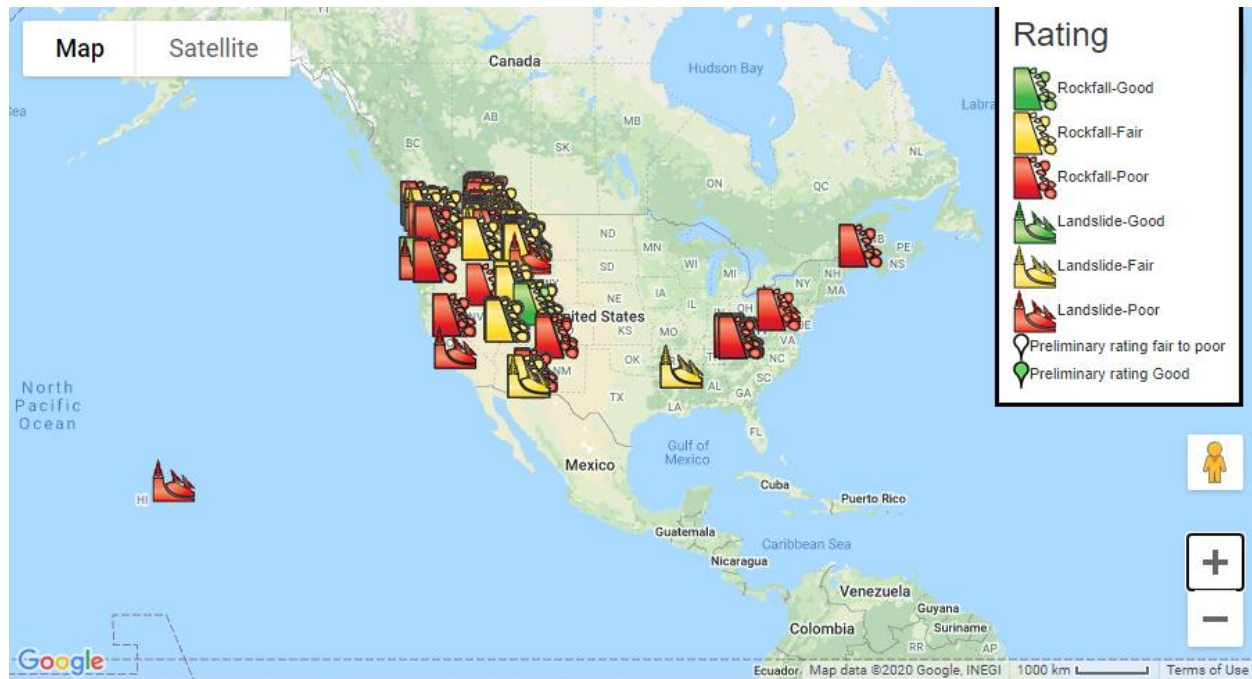
Appendix B. USMP map showing unstable slopes that have been submitted throughout the United States. 284 slopes were rated (including 5 categorized as landslides); 4 slopes were rated 'good', 147 'fair', and 133 'poor'.
