An Analysis Of The Conventional Wire Maintenance Methods
And Transition Wire Integrity Programs
Used In The Aviation Industry

A thesis
presented to
the faculty of the Department of Technology
East Tennessee State University

Keywords: Aircraft wiring, Aging Wiring,
Wire Integrity Programs

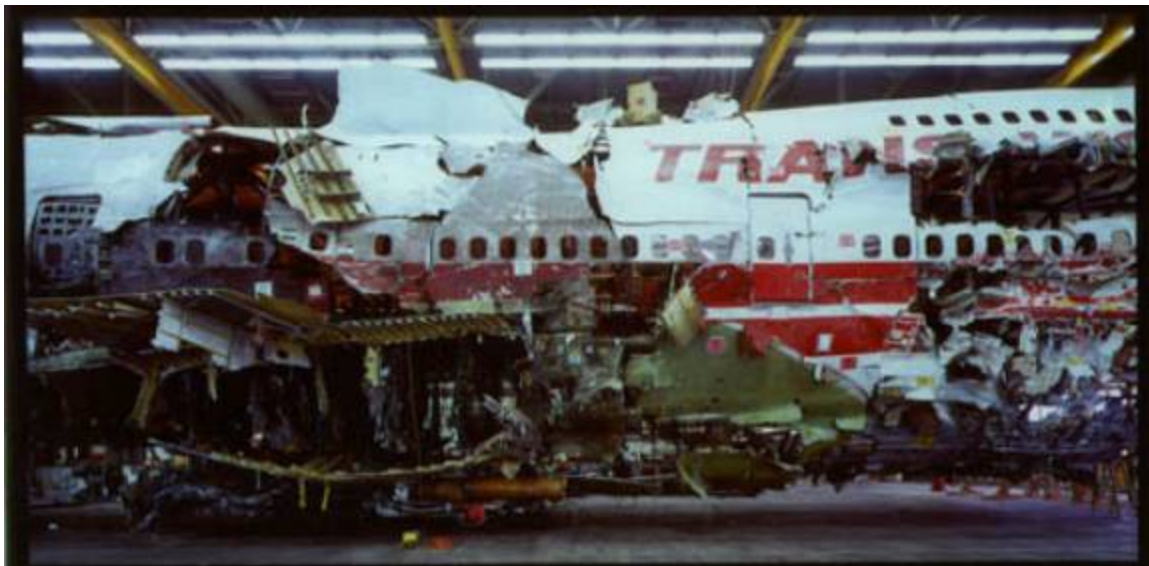
Figure 1. TWA Flight 800: The Reconstruction (1999).

Figure 1 shows the wreckage from TWA flight 800 (TWA flight 800: The Reconstruction, 1999).

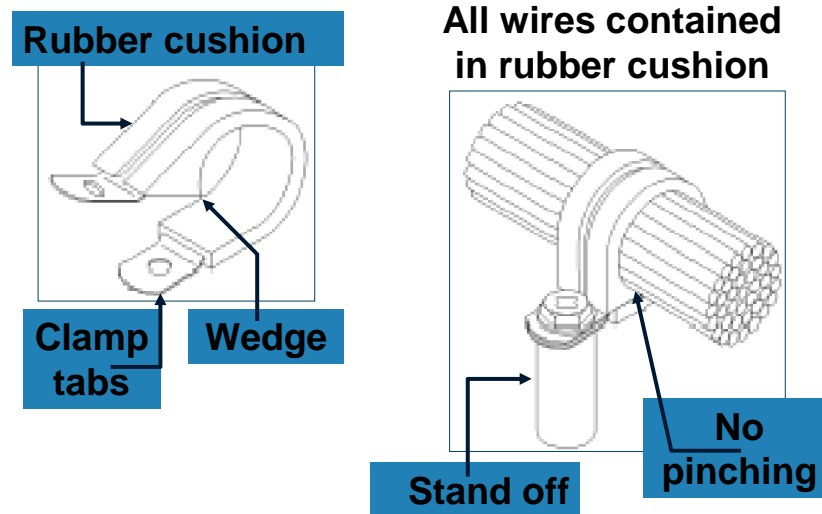
Figure 5. Typical Rubber Clamp (Aircraft Wiring Practices, 2002).

Clamp pinching is a frequent problem in aircraft wiring. This takes place when there is too much wiring in a clamp or when the clamp is not properly installed. To solve this problem, clamps on wire bundles should be chosen to have a snug fit without pinching wires (Aircraft Wiring Practices, 2002).

Figure 5 illustrates a typical rubber clamp (Aircraft Wiring Practices, 2002).

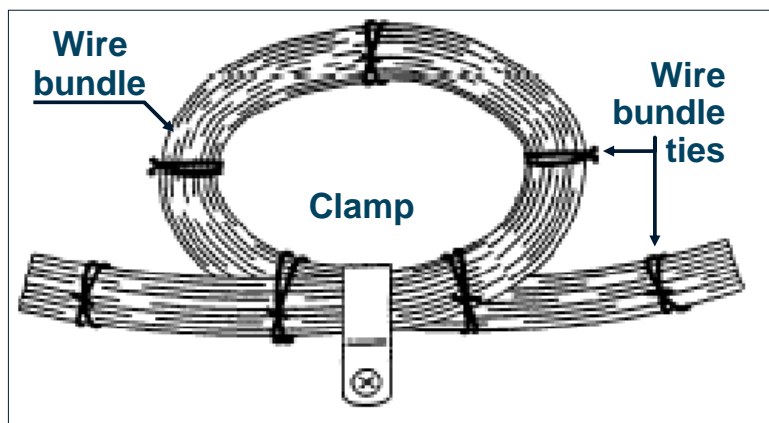
Figure 9. Coil and Stow Methods (Aircraft Wiring Practices, 2002).

Figure 9 shows coil and stow methods used to secure wire bundles (Aircraft Wiring Practices, 2002).

Coil and stow short/long wire bundles in low vibration areas

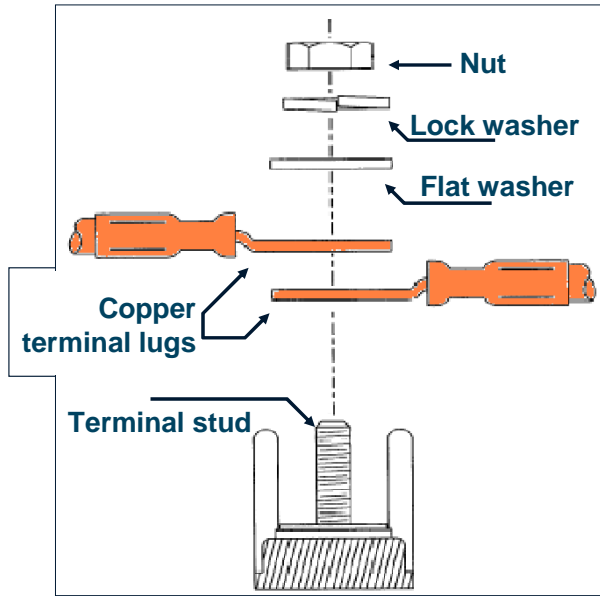
Figure 12. Terminal Stacking Like Materials (Aircraft Wiring Practices, 2002).

Terminals that are made of like materials can be stacked directly on top of each other. On the other hand, terminals that are made of unlike materials, for example aluminum and copper a cadmium-plated flat washer is used to isolate the dissimilar metals. A terminal that is completely assembled should have a minimum of two to three threads showing on the stud when the nut is torqued properly.

Figures 12 and 13 illustrate terminal stacking materials and methods (Aircraft Wiring Practices, 2002).

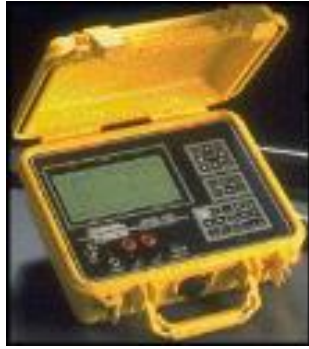
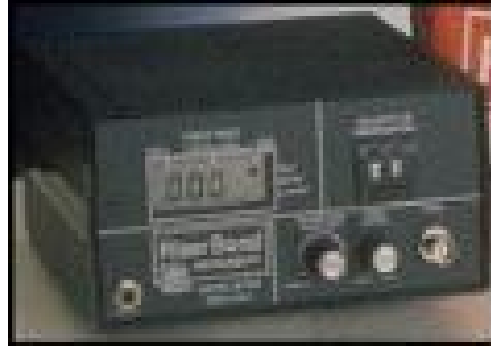
Figure 16. Types of Time Domain Reflectometers (Riserbond, 2004).

A time domain reflectometer can display the information it receives in two formats. The first and more conventional method is to display the actual waveform of the wire. The display, which is either a cathode ray tube or a liquid crystal display, will show the transmitted pulse generated by the time domain reflectometer and any reflections that are caused by impedance changes along the length of the wire. The second method is a numeric readout that specifies the distance in feet or meters to the first major reflection caused by a fault along the wire. Some time domain reflectometers will identify if the fault is an open or short circuit.

Figure 16 shows the different types of time domain reflectometers (Riserbond, 2004).

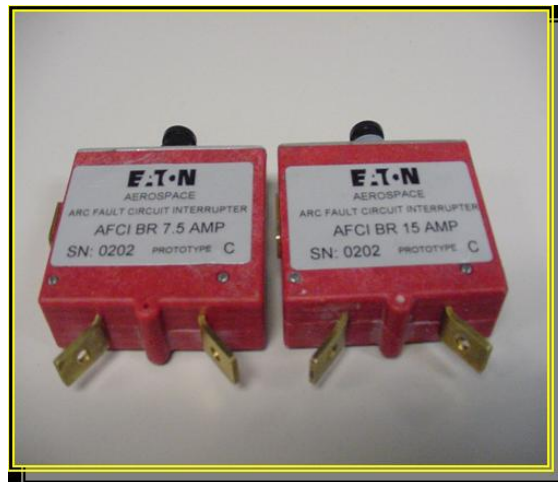
Figure 19. Eaton Arc Fault Circuit Breakers (Arnason, 2001).

Most testing of the arc fault circuit breakers has been carried out by the commercial airline industry with several aircraft firms using them on an experimental basis. Quantas Airlines has flown more than 1,000 hours on an arc fault circuit breaker designed by Eaton Aerospace, whereas Delta Airlines has already started installing them aboard their Boeing 737s (Phillips, 2004).

Figure 19 shows Eaton arc fault circuit breakers (Arnason, 2001).
